Microstructural analysis in asymmetric and non-balanced composite cylinders damaged by internal pressure

Gerson Marinucci* , Arnaldo H. P. de Andrade

Science and Technology Materials Centre
Nuclear and Energetics Research Institute

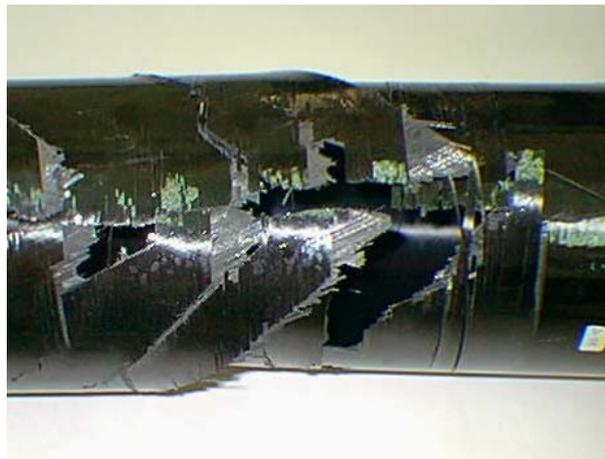
Figure 1- Macroscopic aspect of the cylinder C1 after the collapse.

An examination of the collapsed cylinders show different failure modes, as shown in figure 1. Macroscopically, there is evidence of a long longitudinal crack, having a translaminal fracture in mode I. This failure is characteristic of structures that are loaded only in tensile stress in the hoop direction under hydrostatic pressure. The failure opened the cylinder in the longitudinal axis from one end to the other.

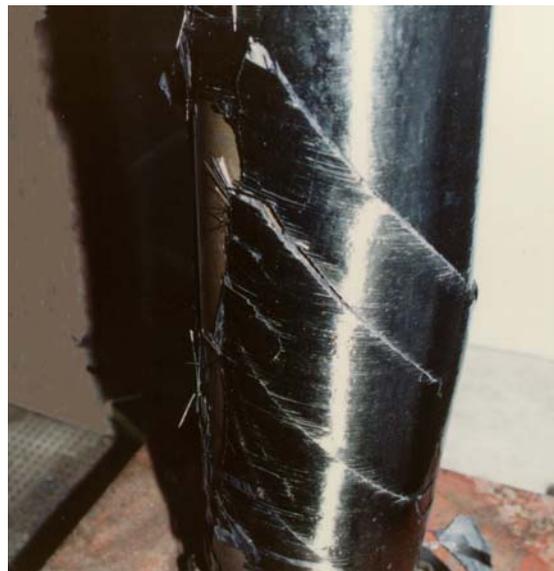
In spite of pure uniaxial hoop loading, evidences of shear tension were observed in planes of maximum shear stress, causing helical cracks at 45° in relation to the cylinders axis, as shown in figure 2. This phenomenon may have increased by the stacking sequence used to build the cylinders, which resulted in non symmetrical geometry, that caused undesirable bending and torsional effects. These effects can be anticipated by a mathematical analysis presented by Jones [16], due to the presence of the coupling matrix (named as matrix [B]), that appears as a consequence of the asymmetry. The presence of the matrix [B] in the mathematical analysis, shows that the loading could not have only produced extensional and shear deformations but also bending and torsion deformations in the structure.

Figure 2- Helical cracks in the cylinder C3.

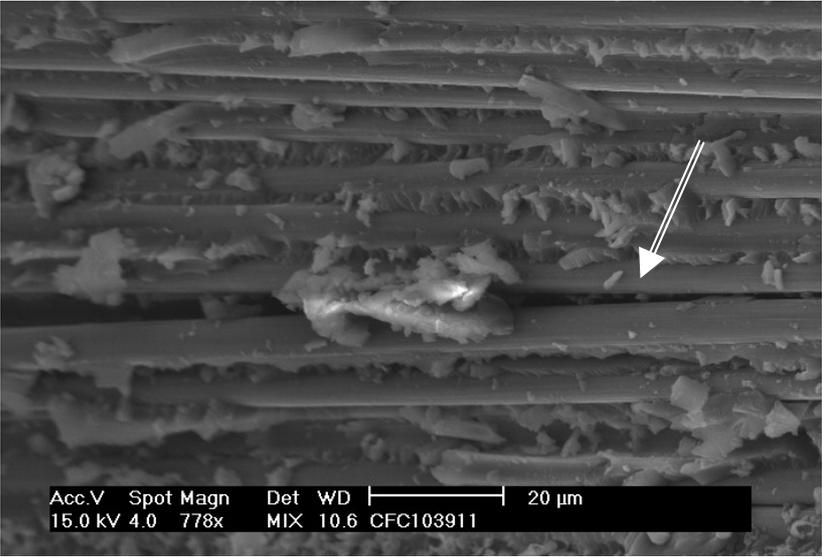
that will cause debonding in the fibre/matrix interface and microcracks transversal to the loading direction. Figures 3 and 4 show respectively a debonding failure in the cylinder C2 and a transverse crack in the cylinder C4, both occurring in helical layers of 25°, characterizing an interlaminar failure.

Figure 3- Debonding effect in the helical layer of 25° of the cylinder C2.

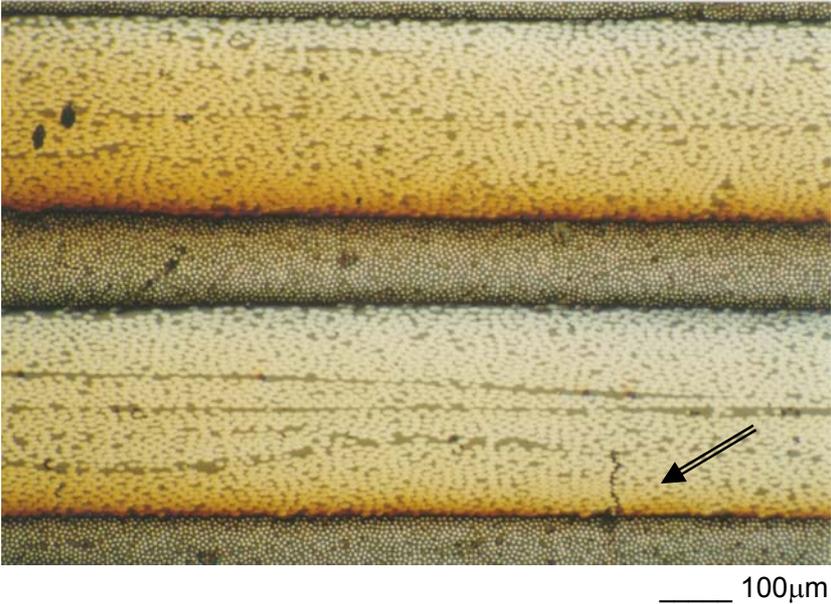
Figure 4- Transverse crack in the matrix of the cylinder C4 (first helical layer).

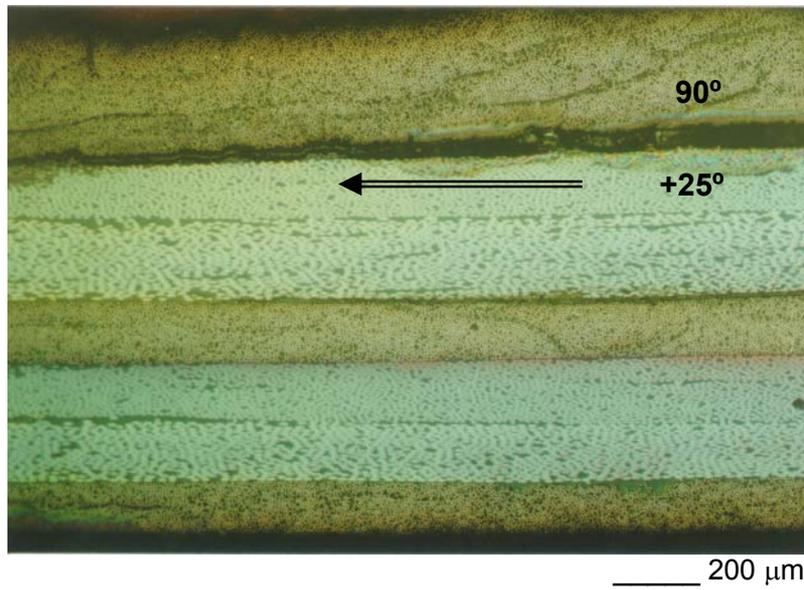
Figure 6- Delamination between the helical layer of 25° and the hoop layer, in a sample of the cylinder C4.

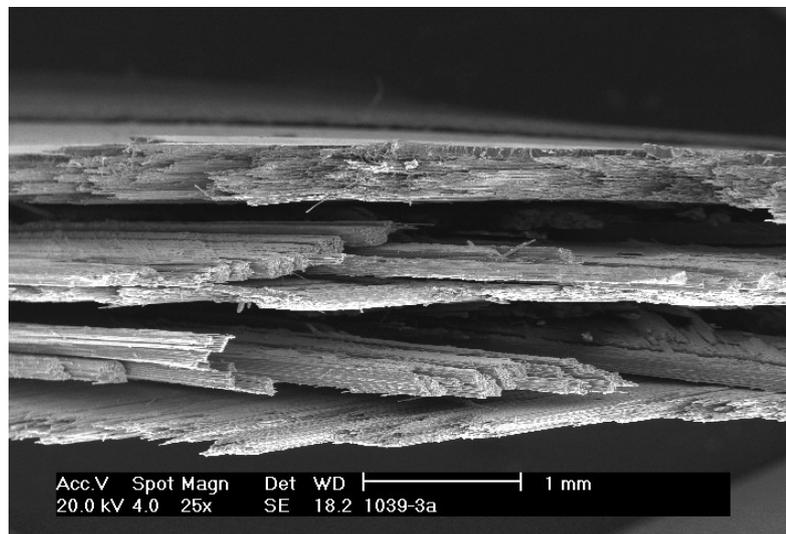
Figure 7- Photomicrographs showing the transverse section of the cylinder C5, outstanding the delamination among the layers.

Fibres fracture in the direction of the main tension is the worst damage that can happen to polymeric composites that use continuous filaments, as they are effectively responsible for the structural strength of the composite. Figure 7 shows the layers, in the ascending order, totally separated in a clear indication of shear interlaminar failure of mode II.

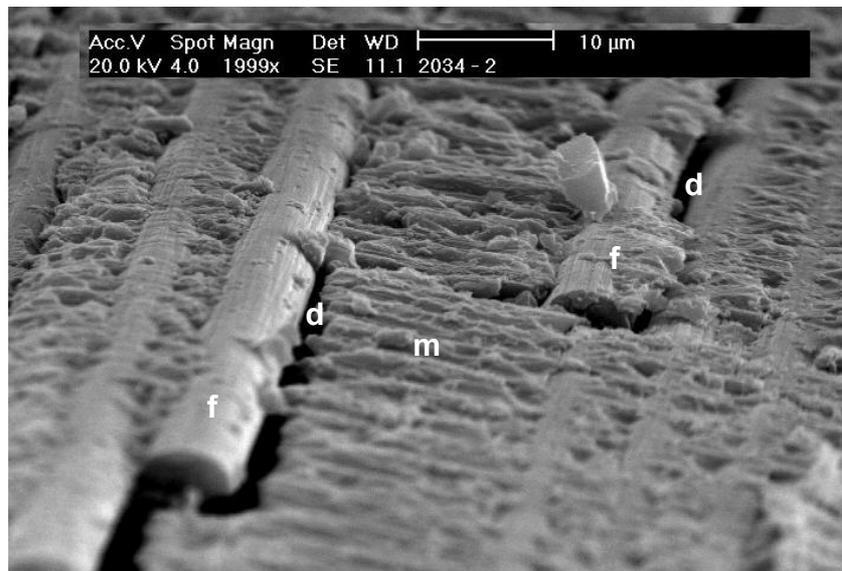
One example of fractured filaments in hoop direction is shown in figure 8. This figure shows the intermediate layer of 90° of a sample of cylinder C1. The breakage of filaments (f) caused some cracks in the matrix (m), producing localized debonding (d). If these cracks had continued along the filament they would have resulted in an increased debonding effect at fibre/matrix interface, eliminating the capacity of these filaments to withstand the loading. In this region, eventually due to the increased loading, a stress concentration could occur, causing the failure of filaments that are in the nearest neighborhood, which eventually would result in the failure of the layer. A model proposed by Bader [17] to explain failure behavior of uniaxial fibre composites is shown in figure 9.

Figure 8- Fractured fibre in the hoop layer of cylinder C2.

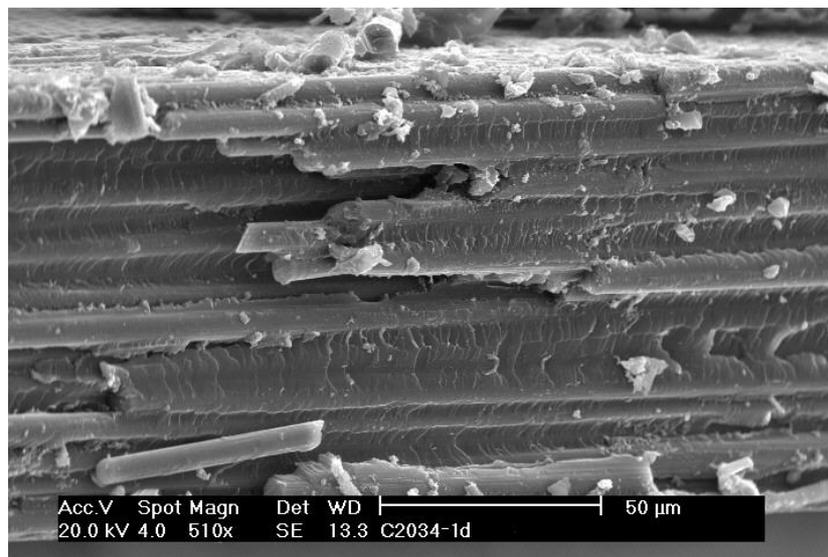
Although the fracture of the fibres begins in the inner helical layer, causing failure of the filaments by transverse tensile stress, composites that have a good bonding interface show a feature, named by Purslow, in his work with plates, wavy radial patterns [6]. Figure 10 exhibits an example of an intralaminar failure caused by transverse tensile stress in cylinder C5.

Figure 10- Failure due to transverse stress in the cylinder C3.
