# On the Failure Behaviour of a High-Frequency Loaded CFRP-Composite

Wolfgang Förtsch<sup>1</sup>, Horst E. Franz<sup>1</sup> and Klaus Friedrich<sup>2</sup>

<sup>1</sup> EADS Corporate Research Center Germany  
Surface Technology and Chemical Engineering - Physical Analyses and Failure Analyses

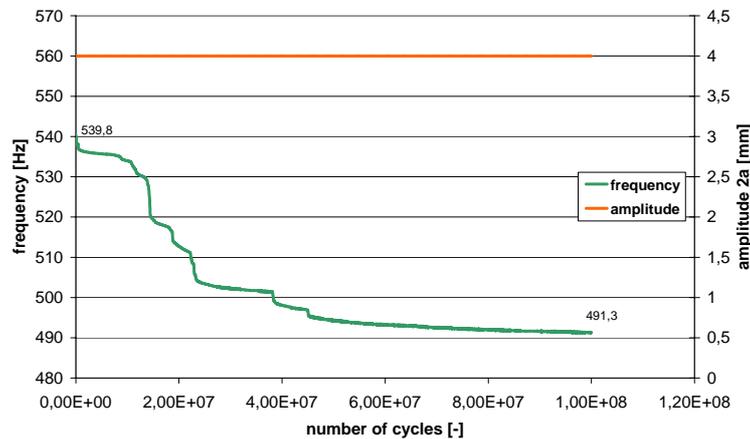
Fig.3. Typical drop in frequency plotted against the number of cycles

It appears that the drop of frequency occurs in stages, indicating an unsteady course of failure within the structure. Up to a constant load with an amplitude of 3 mm the number of cycles does not result in a decline in the natural frequency ( $\approx 540$  Hz) of the material. The first drop in frequency is determined at an amplitude of 4 mm. This corresponds to a load of only 18% of  $\sigma_{\max}$  with a decline in frequency of approx. 9%. The size of the drop in frequency and the shape of the curve in the form of stages are subject to a wide scatter. Nevertheless, a constant increase in frequency decline may be observed with rising load and a form of load limit value is established. At this point there is a complete breakdown in the natural frequency and ultimately component failure occurs. This limit value is established at an amplitude of 11 - 12 mm and this corresponds to a real load of approx. 50% of the minimum static failure stress.

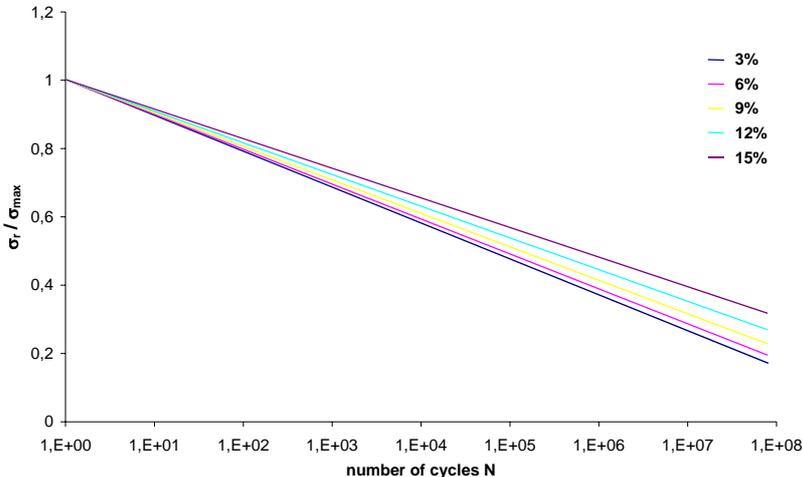
As a result of these individual tests it is possible to plot life-cycle diagrams similar to Wöhler diagrams (Fig.4). As in Wöhler diagrams, the relative maximum load  $\sigma_r/\sigma_{\max}$  is plotted against the number of cycles or loading time. The life-cycle-lines are drawn in the life-cycle diagram as lines of equally decreasing frequencies in the form of logarithmic regression lines. The correlation between the decrease in frequency and the extent of damage means that the lines represent threshold lines defining the extent of the damage.

The permissible stress limit for the examined specimen geometry is between approx. 20-40% of the failure stress  $\sigma_{\max}$  for a limiting number of load cycles of  $10^8$  as a function of the

**Fig.4.** Lines of equally decreasing frequencies

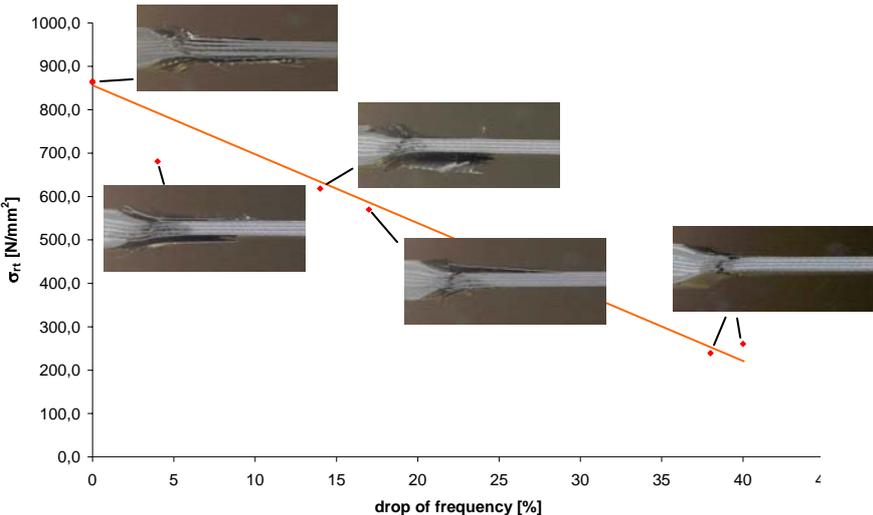
The residual tensile strength following fatigue load was measured in a tensile test (Fig.5). The low number of samples means that it is not possible to establish an unambiguous linear correlation between the residual tensile strength and the decline in frequency. However, there appears to be a very strong decline in the values down to approx. 30% of the static tensile strength of the undamaged specimen.

**Fig.5.** Strength after fatigue loading as a function of fracture

The high loss of strength already evident with a low drop in natural frequency indicates that very substantial damage occurs locally in the material. This can also be seen with the varied occurrence of fractures following failure in the tensile test. As the fall in frequency increases accompanied by a greater local weakening of the material, the length of the delaminations

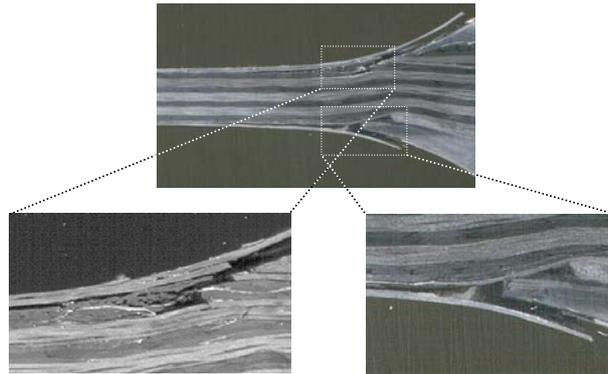
**Fig.6.** Cross section of the failed region (24% drop in frequency)

The micrographs showed that the main damage took place in the area of the resin pocket and the directly adjacent layers. A sample with only a 9% drop in frequency showed two cracks aligned vertically along the direction of load in the resin pocket and a delamination failure only in the directly abutting fabric layers (Fig 7). Also a specimen subject to high load (Fig. 6) evinces cracks transverse to the direction of load in the resin pocket. However, in addition to delaminations at the outer layers, there are separations of the resin pocket from its surroundings. Complete delamination of the outer layers may occur through to translaminar failure, i.e. complete fracture of the laminated fibre bundles. The resin pocket is completely rubbed off, in the same way as the opposing structure subject to the maximum load, where the upper  $0^\circ$  layer is delaminated without translaminar failure, whereas the  $\pm 45^\circ$  and  $0^\circ$  layer beneath are destroyed locally.

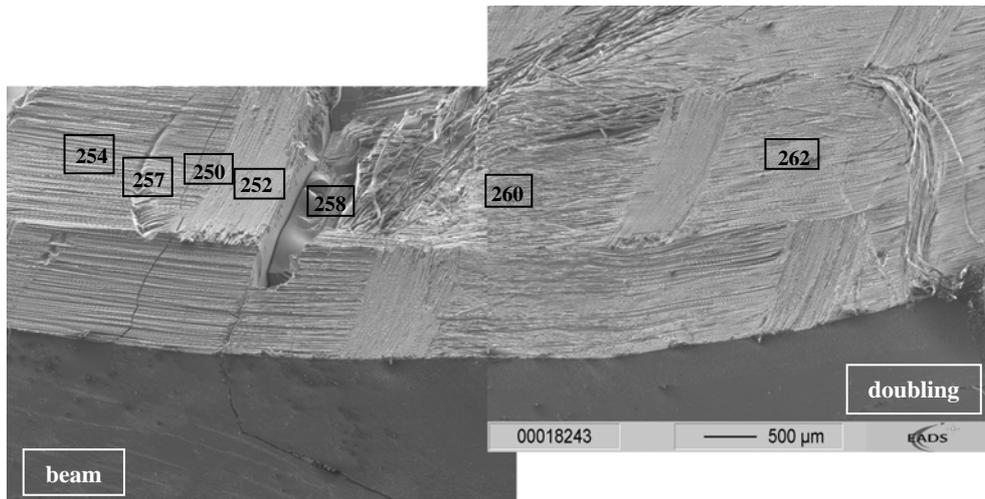
Fig. 7 shows a side view of the fracture surface of a specimen with 9% drop in frequency. The arched fronts where the primary front of fatigue crack propagation is blunted are clearly visible in the direction of the beam. The cracks running in the resin pocket and their continued propagation in the material are also clearly visible. These cracks may show some major disruptions of the resin due to crack branching. Points in the picture were marked with numbers to show characteristic features in the microfractographic tests. Alternatively, they were investigated with a view to understanding the chronological progress of the failure.

**Fig.7.** SEM image of a fracture surface for a sample with 9% drop in frequency

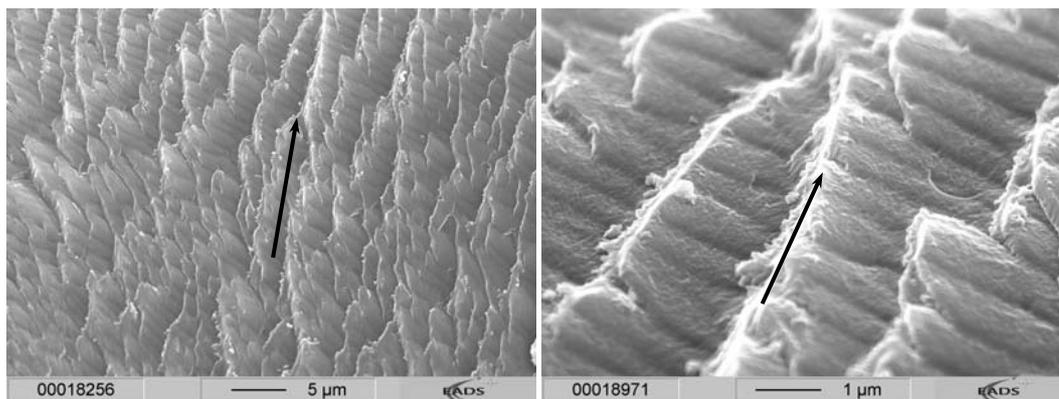
**Fig.8.** Fatigue striations on a scaly area (257), tilt angle: 45° (The arrow indicates the fracture direction)

When they are lined up, they are on separate planes perpendicular to the fracture direction. The corresponding structures can be seen on the matching fracture surface. Crack propagation appears here at different fracture planes which run in the direction of fracture and propagate into each other in scarp formations. The blurred demarcations of the scaly structure stand out as a wavy form and represent probably the cyclic component of the fracture morphology as fatigue striations. This would present an unambiguous proof of fatigue failure in this area.

Fatigue failure under predominant mode I component appears to be present in the whole area. This may also be expressed as typical scarps on the fracture surface and the local fracture direction can be determined from them. If the specimen is tilted a sharp angle, the fatigue striations overlaying the whole structure may be seen (Fig. 8, right).

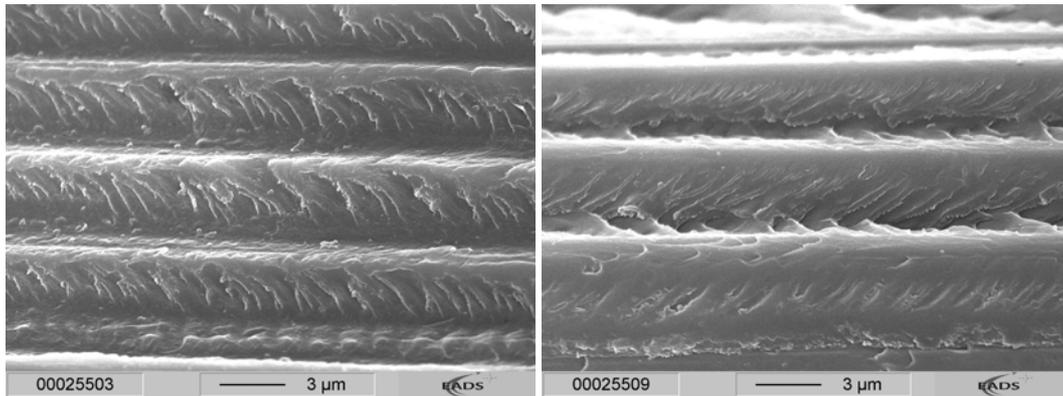
Quite different fracture characteristics may be found in area 250 between the two transverse cracks in the resin pocket where the local fibre orientation runs parallel to the load direction. Radiating out from the fibre beds, the fracture phenomena have a lamellar structure which partly reunites at the top and forms a closed surface (Fig 9, left). No imprints of the fibre surfaces are to be found in the fibre beds. A corresponding fracture structure can be seen on the matching fracture surface (Fig. 9, right). The fibres are completely coated in resin and are

simultaneously fixed by the lamellar structure. By comparing fracture surfaces and matching fracture surfaces, it may be seen that pure matrix failure is present as a cohesive fracture of the resin, i.e. no interface failure takes place.

**Fig.9.** Fracture surface and matching fracture surface in area 250, tilt angle: 45°

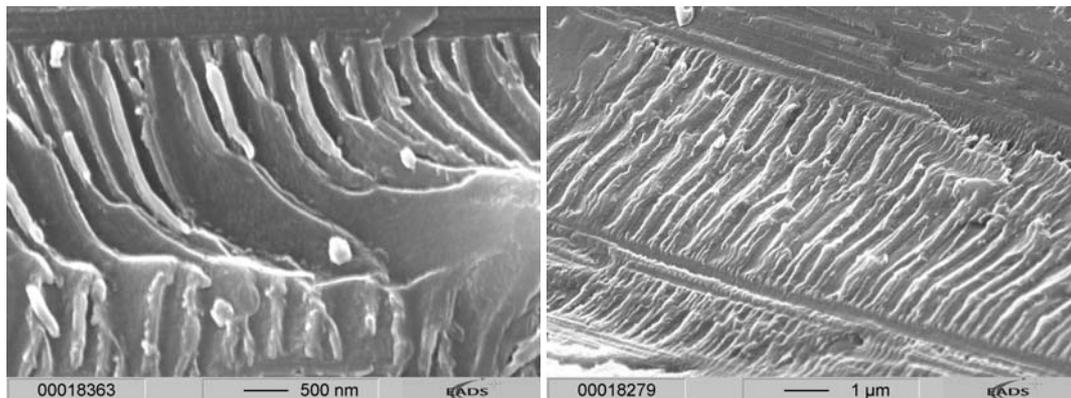
**Fig.10.** Left: Fracture morphology in (258), Right: Area between fibre imprints in (260)

The fracture characteristics found in the base of the resin pocket (area 258) correspond to the features in 250. The lamellar structure is more distinct, although this may be caused by a bigger fibre distance prevailing locally. Interface failure also takes place along the fibres. The magnification (Fig. 10, left) shows that the cracks were initiated in each case along the fibres being propagated into the inter-fibre areas.

The occurrence of characteristic fracture features is different in the areas 260 and 262 between the resin pocket and clamping. The area near the resin pocket shows an essentially less distinct structure formation (Fig. 10, right). This suggests a comparison with mode II fatigue fracture loaded at low frequency. The occurrence of the morphology in the inter-fibre areas resembles a fracture surface after roller formation, although these are not to be found.

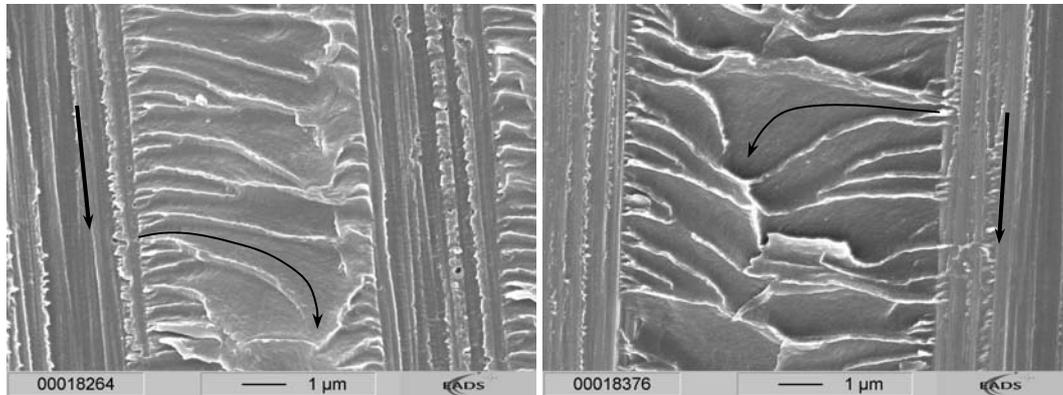
A much more distinct shape for the fracture characteristics is found in the area 262. The fibre direction also corresponds here to the macroscopic fracture direction, although the fracture

runs in the interface between fibres and matrix. At higher magnifications it may be seen that interface failure appears with the local fracture direction in the inter-fibre areas lying perpendicular to the macroscopic fracture direction (Fig. 11). In the further course of the emerging fracture planes, it may be seen that these fracture planes tend to be oriented in the direction of the primary crack front according to a static fracture under mixed-mode conditions.

**Fig.11.** Fracture surface and matching fracture surface in 262 (The arrow indicates the fracture direction)

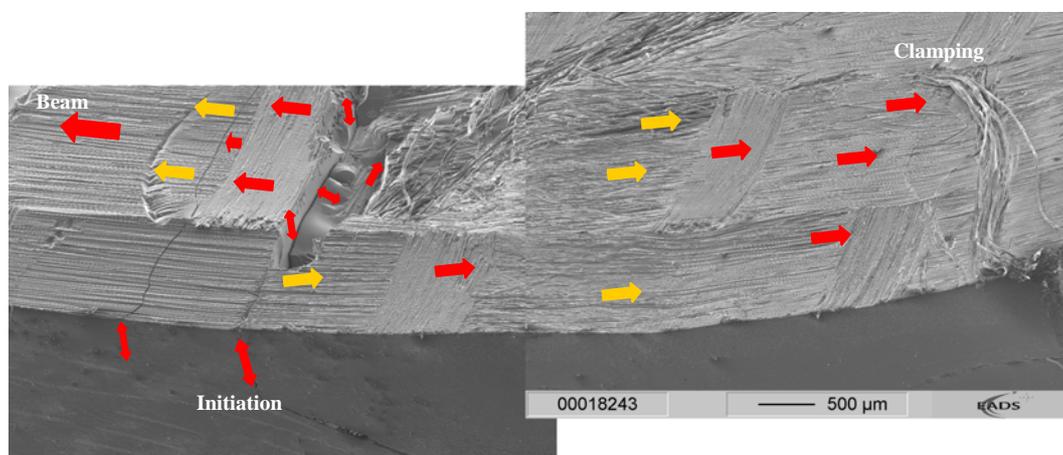
When loading commences, static mode I transverse cracks appear in the resin pocket (Fig. 12). This exerts an effect later as initiation sites for fatigue crack propagation. These cracks propagate further primarily under predominant mode II load in the direction of clamping within the outer layers along the line of maximum load. Decelerated crack growth takes place in the direction of the beam. A change in the loading mode takes place in both directions, starting initially with nearly pure mode II load moving to a predominant mode I load by the end of crack propagation. If progressive damage occurs or the load is increased, the stress field and crack propagation are also shifted within the material. Additional damage propagation means that the bearing cross-section decreases in size and the supporting matrix structure is increasingly destroyed, since total failure occurs in the form of a complete frequency breakdown.

**Fig.12.** Course of fracture on the fracture surface (yellow: fatigue fracture, red: static fracture)

This makes it possible to explain the strong correlation between decrease in frequency and residual strength. The cross-section at the radius will be severely damaged locally and shows a small drop in frequency under minor loads. This means that the residual strength decreases significantly. Due to its dependence on local damage events, the residual strength is substantially determined by the local discontinuities. The residual strength could be improved by minimizing these crack initiation points.
