FATIGUE FAILURE OF A COMPOSITE SANDWICH BEAM CONTAINING A CENTRAL NOTCH

ABSTRACT

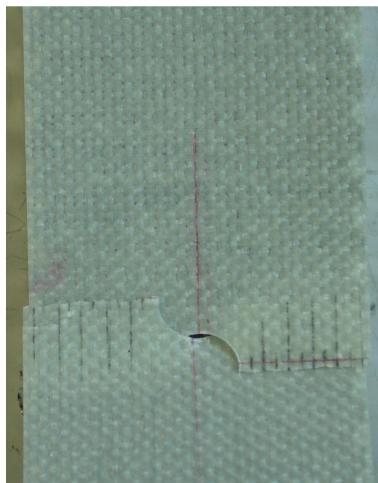
Figure 3 shows examples of the failed specimens in Region 1 (figure 3(a); compressive face), and Region 2 (figure 3(b); tensile face).

Figure 3: (a) Compressive face of specimen after fatigue failure (Region 1). (b) Tensile face of specimen after fatigue failure (Region 2). The specimens are 70 mm wide.

Failure of the beams with peak fatigue loads above 70% of the quasi-static failure load occurred in two stages: slow growth of fatigue cracks initiating from the notch, followed by catastrophic failure. Figure 4 shows an example of the increase in the length of cracks in a specimen tested with a peak fatigue load 80% of the quasi-static strength. As figure 4(a) shows, the crack on the left side of the notch initiated after about 500 cycles and grew slowly, to a length of about 5 mm after 1100 cycles (point B in figure 4(b)), and then continued to grow slowly to point D over the next 700 cycles. By contrast, the crack on the right side of the notch grew to a length of 5 mm (point A) after about 500 cycles, but then did not grow further. The specimen failed when the combined length of the cracks, together with the 15 mm diameter initial notch, was about 33 mm. The paths of the crack growth in relation to the underlying core structure are shown in figure 4(b). These paths can be determined because the GFRP skins are sufficiently transparent for the honeycomb core to be seen using high intensity transmitted light.

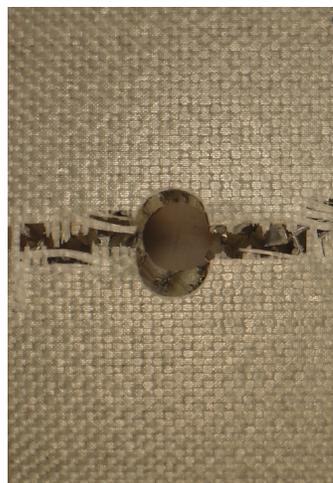
(b)

In Region 2, i.e. for peak fatigue loads equal to 70% or less of the peak quasi-static failure load, the number of cycles to failure was considerably higher. For example, for a peak fatigue load 70% of the quasi-static failure load, the number of cycles to failure varied between 22,500 and 31,000; for 60%, the number was between 17,500 and 75,000. Furthermore, in Region 2, failure of the sandwich panels occurred on the tension face of the sandwich panel, suddenly and catastrophically, without any obvious evidence of damage prior to catastrophic failure.

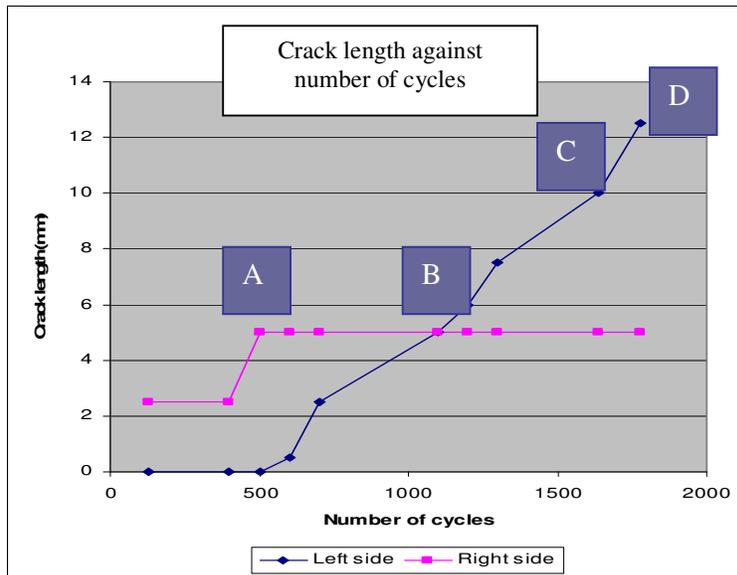
Figure 4: (a) Growth of cracks on the left and right sides of a hole for a beam fatigue loaded with a peak load 80% of the quasi-static failure load. (b) Path of crack growth relative to the aluminium honeycomb core.

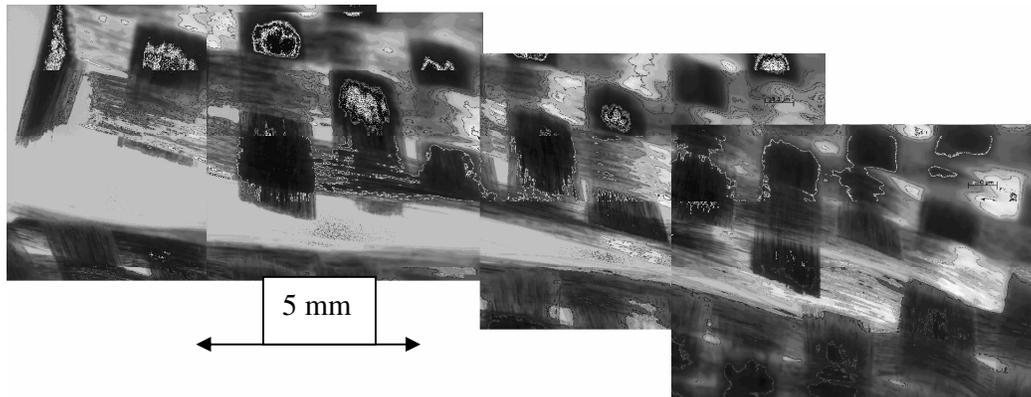
Sectioning the specimens perpendicular to the direction of the crack growth in the compressive skins, suggested that the fatigue cracks grew as tow buckling failures which propagated during fatigue cycling. Figure 5 shows the result of a burn-off test on the compressive skin of a specimen, showing the inner layer of the two-layer fabric of the skin after the initiation and growth of a fatigue crack; the hole is on the left of the image. It can be seen that the crack has fractured about 8 tows as it propagated a distance of about 18 mm across the width of the specimen from the hole. It appears that the growth of the fatigue damage on the compressive face of the sandwich beam from the hole is similar to the microbuckling initiation and growth seen in notched CFRP laminates [8].

Figure 5: Tow fractures in a layer of woven-glass fabric on the compressive face of a beam as a consequence of crack propagation in fatigue.
