PERFORMANCE MONITORING OF REINFORCED CONCRETE WRAPPED WITH FRPs

H. Karpate, H.G. Wheat, J.O. Jirsa, D.W. Fowler, and D.P. Whitney

University of Texas at Austin Cockrell School of Engineering
1 University Station C2200, Austin, TX USA
hwheat@mail.utexas.edu

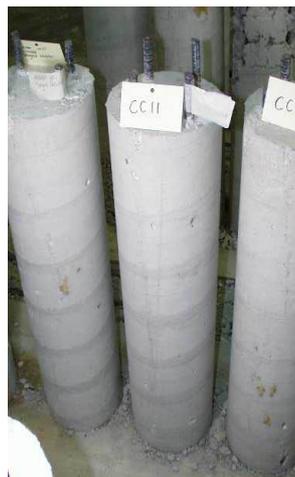
Figure 1: Photograph of selected cylindrical specimens showing the metal cages [1].

In the initial phase of the investigation, 18 rectangular and 42 cylindrical specimens were cast to represent elements of the bridge components; specifically bridge bents and columns. The cylindrical specimens were 91.4 cm (3 ft) long and 25.4 cm (10 in) in diameter. The rectangular prisms were 91.4 cm in length, with a 25.4 x 25.4 cm cross section. Specimens were constructed with steel cages that were formed of longitudinal and transverse reinforcement tied together with metallic tie wires. The reinforcing bars were cut into 99.1 cm lengths so that 7.6 cm of reinforcement protruded out of one end of the rectangular and cylindrical specimens. A high water: cement ratio of 0.7 was used as well as a low cover of 25 mm (1 inch). This was done to ensure enhanced chloride migration through the concrete. The specimens included ones with a number of variables, including the presence or absence of chlorides in the mix water, the presence or absence of flexural cracks, the presence or absence of a single type of spray-on inhibitor (type C), and different repair materials (patch repair or latex modified grout (LMG)).

A photograph of selected cylindrical specimens is shown in Figure 1; a photograph of one of the rectangular specimens is shown in Figure 2; and a photograph of a portion of one of the bridges is shown in Figure 3.

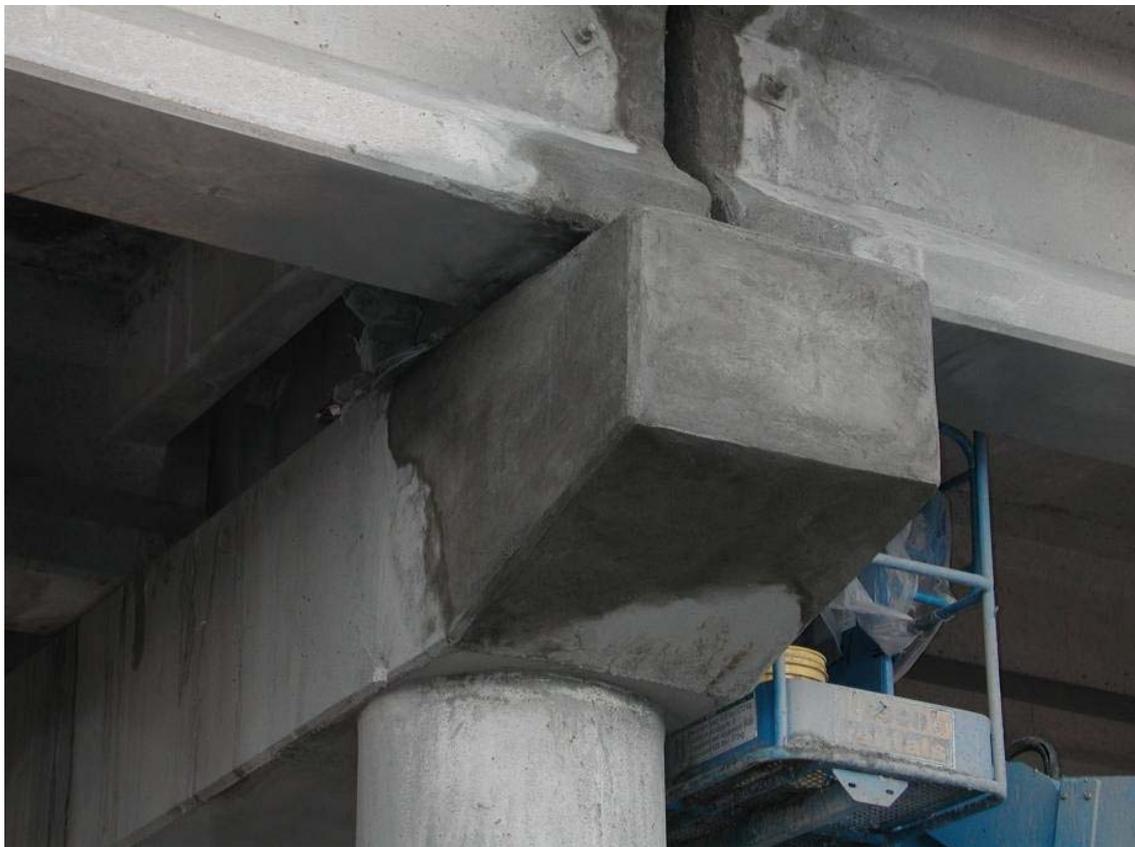
Figure 3: Photograph of a portion of one of the bridges in the field investigation [5].

In the case of the field investigation, 12 bridges were wrapped and corrosion rate probes were installed in strategic locations in three of the structures. Wrapping of the bridges was completed in the fall of 1999. Two probes were installed in selected bents of structure 7, four were installed in selected bents of structure 8, and two were installed in selected bents of structure 12. Corrosion potential readings and corrosion rate probe measurements were taken in May of 2000, October of 2000, and May of 2001. Corrosion potentials were measured in April of 2006.
