EXPERIMENTAL INVESTIGATION OF COMPOSITE PATCH REINFORCED CORRODED STEEL PLATES IN STATIC LOADING

Nicholas G. Tsouvalis, Lazarus S. Mirisiotis and Theodora E. Tsiourva

Shipbuilding Technology Laboratory, School of Naval Architecture and Marine Engineering,
National Technical University of Athens, GR-15773 Zografos, Athens, Greece
tsouv@mail.ntua.gr

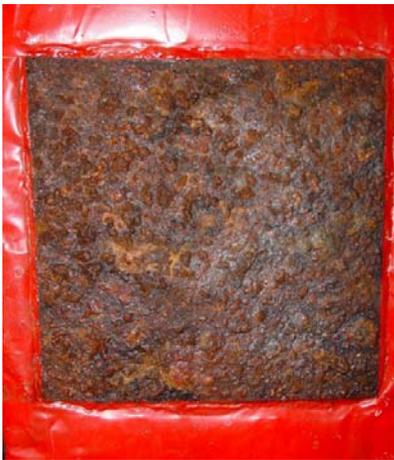
Figure 2: Specimen S-COR-VI-1 after its removal from the salt spray chamber.

The accelerated cyclic corrosion testing was performed according to ISO 14993:2001 standard. A salt spray chamber was used in order to apply the standard. The solution used in the chamber was NaCl 3.5%, which corresponds to the typical NaCl concentration of sea water. Details for the chamber used and the accelerated corrosion procedure followed can be found in [11]. The specimens were subjected to cyclic conditions of accelerated corrosion for 70 days (approximately 200 corrosion cycles). Figure 2 shows a close view of the corroded area of a specimen, just after its removal from the chamber. Cleaning of the specimens and removal of corrosion products was done in accordance with the requirements of standard ISO 8407:1991.

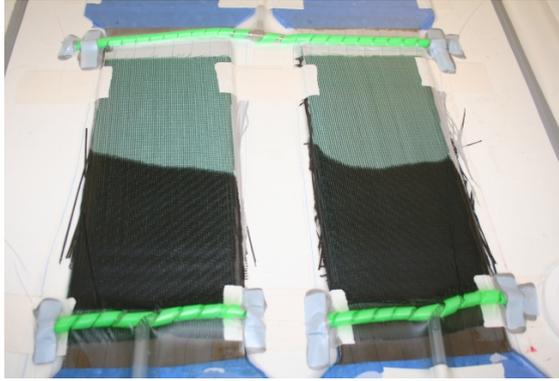
Figure 3 shows an intermediate stage of the vacuum infusion procedure of the patches of specimens S-COR-VI-1 & 2. The number of layers and, hence, the patch thickness, t_p , were defined on the basis of a desired value for the stiffness ratio (SR), according to the equation $t_p = (SR \cdot t_s \cdot E_s) / E_p$, where t_p and E_p are the patch thickness and Young's modulus, respectively, and t_s and E_s are the steel plate thickness and Young's modulus.

Figure 3: Vacuum infusion of specimens S-COR-VI-1 & 2.
