FATIGUE FAILURE OF A COMPOSITE SANDWICH BEAM CONTAINING A CENTRAL NOTCH

ABSTRACT

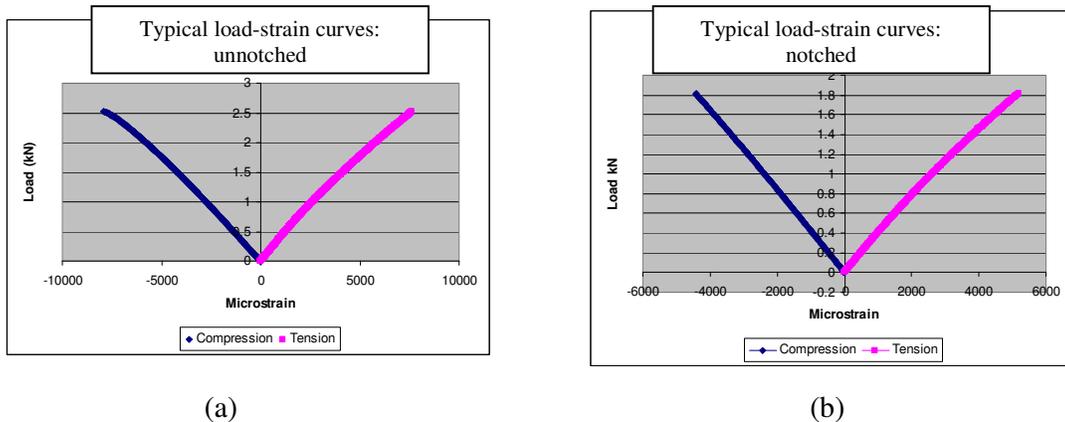
Typical load-strain curves for the unnotched specimens are shown in Figure 1(a). The figure shows the load plotted against the longitudinal strains measured on the compressive and tensile faces. In general, these curves were non-linear above about $1000 \mu\epsilon$. Above about $3000 \mu\epsilon$, the strain measured on the tensile face was slightly higher than on the compressive face, with a strain to failure on the tensile face of $8000 \pm 400 \mu\epsilon$ and on the compressive face, $7600 \pm 100 \mu\epsilon$, for an average load to failure of $2.55 \pm 0.09 \text{ kN}$. Under quasi-static loading, a catastrophic failure occurred on the compressive face, anywhere within the region of constant bending moment between the inner rollers. The fracture line extended roughly parallel to the width direction of the specimen, with an overlapping of the face material occurring at the fracture line.

The notched specimen also failed by local buckling, but this time the fracture always propagated through the notch and was presumably initiated by local buckling [7]. Typical load-strain curves for notched specimens are shown in figure 1(b). The mean failure strain (and standard error) measured for the notched specimens were $5700 \pm 400 \mu\epsilon$ (tensile face), $5400 \pm 200 \mu\epsilon$ (compressive face) with a failure load of $1.95 \pm 0.06 \text{ kN}$. Interestingly, the notched failure load is 24% lower than the unnotched failure load which is very close to the reduction in the net-section cross-sectional area due to the hole (21%), suggesting that the sandwich panel is only very slightly notch-sensitive for this diameter of hole. The face material at the fracture line again overlapped after failure.

Figure 1: Typical load-strain curves to failure in quasi-static loading for (a) unnotched and (b) notched specimens

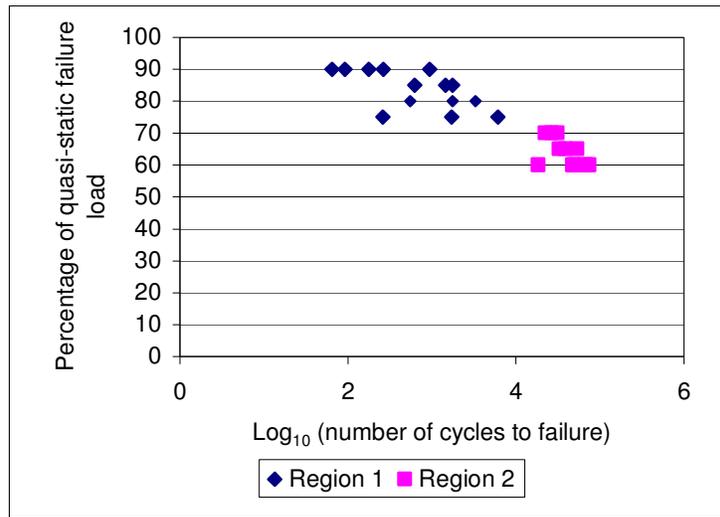
The fatigue test results are shown as normalised S-N curves in figure 2, where the peak fatigue load has been normalised by the average quasi-static failure load. The fatigue test results divide into two regions. Region 1 refers to the higher peak fatigue loads, which correspond to peak fatigue loads above 70% of the quasi-static failure load. In this regime, all of the specimens failed by the development of cracks which initiated on the compressive face of the specimens from the notches; these cracks grew stably as fatigue cracks and grew across the remaining ligament width on each side of the hole until catastrophic failure occurred. For a peak fatigue load which was 90% of the quasi-static failure load, the number of cycles to failure varied between 65 cycles and 930

cycles. At 75% of the quasi-static failure load, the number of cycles to failure varied between 260 and 6100.

In Region 2, i.e. for peak fatigue loads equal to 70% or less of the peak quasi-static failure load, the number of cycles to failure was considerably higher. For example, for a peak fatigue load 70% of the quasi-static failure load, the number of cycles to failure varied between 22,500 and 31,000; for 60%, the number was between 17,500 and 75,000. Furthermore, in Region 2, failure of the sandwich panels occurred on the tension face of the sandwich panel, suddenly and catastrophically, without any obvious evidence of damage prior to catastrophic failure.

Figure 2: S-N curve for the failure of the fatigue failure of the sandwich panels showing Region 1 (failure on compressive face) and Region 2 (failure on tensile face).
