Assessment of a Novel Toughening Procedure for Composite Vacuum Infusion In-Field Repairs

D. Tzetzis¹, P.J. Hogg¹ and M.Jogia²

¹Queen Mary College, University of London, Department of Materials, London E1 4NS,UK

²QinetiQ, Structural Materials Centre, Farnborough, Hampshire GU14 0LX,UK

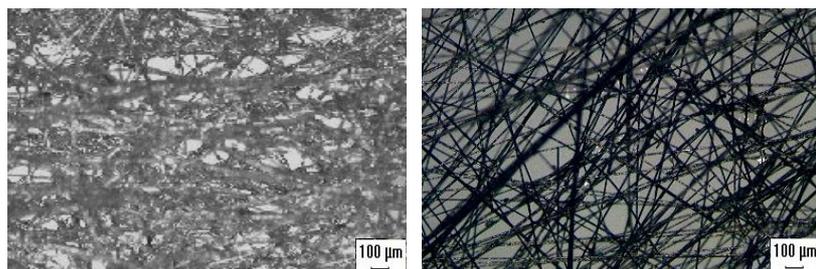
Fig. 1. Optical micrographs of a polyester and a carbon veil used as the toughening phase of the infused bondline

The surface of the parent component was grit blasted for all the repairs studied using a grit mesh of #30/40 and degreased thoroughly with acetone prior to infusion. Some DCB specimens were manufactured by infusing the woven repair fabric plies directly onto the treated surface denoted as repairs without bondline reinforcement, while for the other DCB specimens, polyester veils and/or carbon veils (fibres running at random orientations) were positioned between the treated surface and the repair woven plies. Fig. 1 shows optical micrographs of the veils used. Three configurations were assessed. One with an intermediate carbon veil of 10 g/m², one with a polyester veil of 25g/m² and one with a combination of two layers of polyester veil and in-between a carbon veil (70% polyester fibres and 30% carbon fibres) making a total of three layer configuration. The selection of the veils was based as much for their ready availability as for their prospective performance.

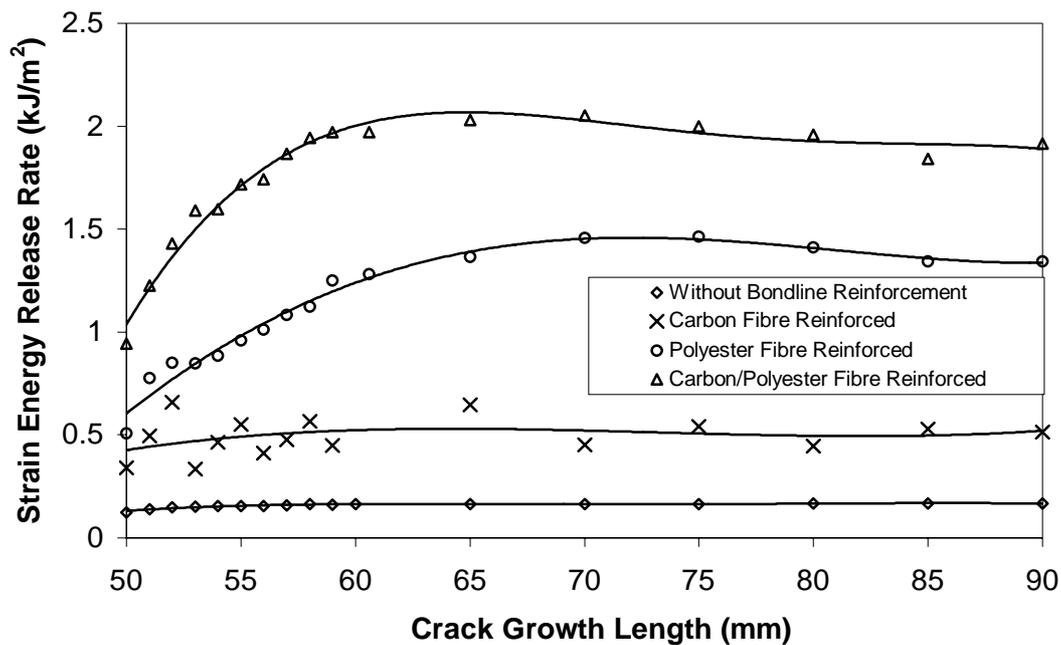
Fig. 2. R-curves obtained from the DCB repair testing

Table 1 shows the critical energy release rate values for the DCB tests while Fig. 2 illustrates typical resistance curves (R-curves) obtained from each type of repair. The results obtained for bonds made without the reinforcing veils reveal a rather weak crack R-curve effect, such that the average of the propagation values, being 0.163kJ/m^2 , did not differ considerably from the initiation value (0.133kJ/m^2) indicating that as the crack length was increased low energy was required to continue fracturing the surface.

DCB repairs reinforced with the carbon veil exhibited much higher initiation (0.421kJ/m^2) and propagation fracture energy (0.474kJ/m^2) values again with small differences between them. At the propagation region there was a clear stick-slip behaviour revealing a rather brittle fracture as expected from the use of the carbon veil. The higher initiation fracture energy compared to DCB repairs without veil was believed to be primarily due to cohesive bondline fracture associated with the infused epoxy resin. This is in contrast to the interfacial fracture related to the Hercules 3501.6 surface resin of the parent prepreg laminate for the repairs without bondline reinforcement. One possibility is that the mechanism of cracking within the infused bondline was linked to the random distribution of the carbon fibres themselves promoting failure at their interface. However, the most probable explanation of the higher critical fracture energy increase is that the presence of the fibres at the bondline from the ultrathin veil and the associated thickness increase created a blunting effect on the crack tip, and therefore increased the critical energy dissipation values compared to repairs without veil at the bondline.

The incorporation of the polyester veil further increased the critical fracture energy of the DCB repair to 0.562kJ/m^2 while a different R-curve pattern was observed revealing that as the crack length was increased indeed more energy was required to continue fracturing the bondline. The noticeable difference was the dramatic increase of the strain energy release rate for the first 10mm of crack growth with the subsequent steady state response thereafter. In this case, the main macroscopic effect responsible for that increase was fibre bridging, which was visible with the naked eye. The high initiation fracture energy was attributed to the very start of the bridging ligament effect and the mechanisms associated with that process. The introduction of both carbon and polyester veils had resulted in an increase in the number of fibres within the bondline. The increase in the number of fibres involved affected the fibre bridging process and resulted in an increase in fracture energy (0.928kJ/m^2), until a plateau value was reached and fibre-bridging saturation occurred.

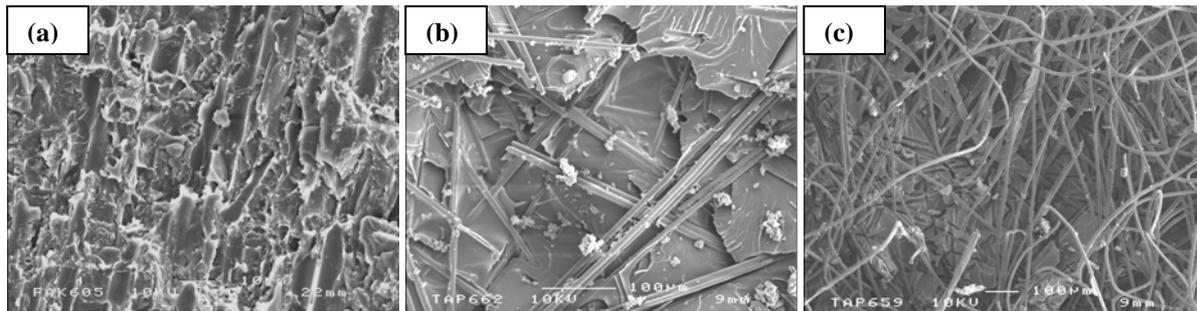
Fig. 3. SEM showing characteristic fracture areas of the DCB repairs a) without bondline reinforcement, b) carbon fibre reinforced and c) polyester fibre reinforced

In the case of repairs without the reinforcing veils at the bondline, certain areas of the parent surface were covered by a thin layer of surface resin; however the dominant failure mode was exposure of fibres suggesting crack propagation close to the surface ply of the parent material. The toughness of the surface resin, as discussed previously, from the Hercules 3501.6 resin system was much lower than the infused LY5052/HY5052 polymerised resin resulting in a preferential fracture path close to the surface fibres. This was verified on the SEM in Fig. 3(a) taken from the fractured specimen where a mixture of fragmented surface fibres and resin is observed.

From the SEM in Fig. 3(b) and Fig. 3(c) it is evident that the incorporation of polyester and carbon veils in the infused bondline region affected the fracture path of the repairs thereby the dissipation of energy. In the case of the DCB repairs reinforced with the carbon veil at the bondline the failure mode showed a cohesive/interfacial fracture area with significant number of broken carbon fibres while both shear hackles as well as brittle cracking from the infused resin were present within the bonded area. A different type of cohesive failure was obtained in the case of DCB repairs reinforced with polyester fibres at the bondline. The crack trajectories followed left behind multiple fibres after significant extension and subsequent plastic deformation from fibre bridging. In the bridging zone, the cracked resin was bridged by intact and/or failed fibres from the polyester veil, which debond, slip and pull out. Fibre fracture occurred when and if the bridging stress exceeded the strength of the bridging unit. Therefore, the role of a bridging zone in the fracture resistance of the repairs was of particular importance as the bridging fibres are responsible for inhibiting further crack propagation by carrying a portion of the applied load. This contributed significantly to the resistance of the bondline to further fracture. The damage zone was believed to develop around the crack tip during the early fracture stages, which is difficult to externally observe, and after it reached a steady state (plateau region) propagated in a self-similar manner along with the crack tip. In that case the debond length of the bridging ligaments became longer as the crack opening increased. In addition, more bridging ligaments failed as the crack opening increased.

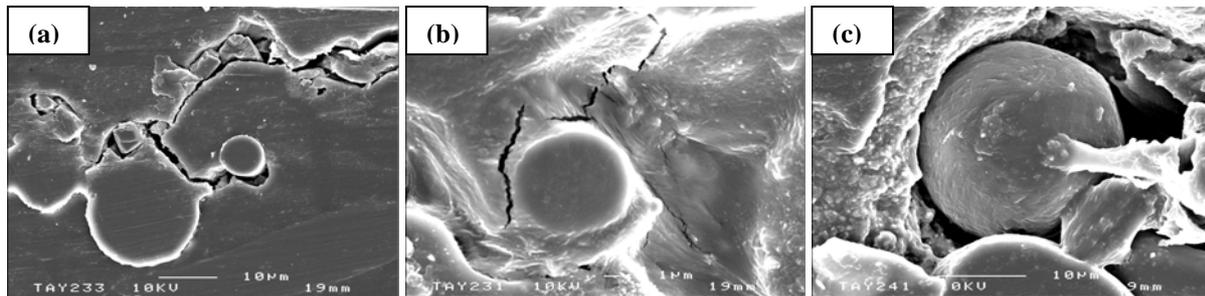
Fig. 4. Cross-section of a carbon/polyester fibre reinforced bondline showing the micro-mechanisms affecting the fracture process a) crack deflection at the crack tip, b) resin/adhesive cracking around a well-bonded carbon fibre within the bondline and c) interfacial failure around a poorly-bonded polyester fibre within the bondline

In addition, the crack deflection mechanism involved cracks being impeded by the rigid fibres. This mechanism arose when the crack encountered fibres especially carbon fibres, and became pinned with a tendency to bow out and form secondary cracks perpendicularly to the direction of the crack. The length of the crack front was increased perpendicularly and energy was required to create these new fracture surfaces. Such a process involved the rupture of intrinsic bonds between the infused resin and the bondline fibres (carbon and/or polyester) an implied localized plastic energy dissipation of the resin in the vicinity of the crack.

Rupture of intrinsic bonds is significantly dependent on fibre surface treatment and nature of the fibre. So for instance, the carbon fibres from the carbon veil were shown to exhibit higher interfacial strength with the epoxy resin compared to polyester fibres. That is illustrated qualitatively in Fig. 4(b) and Fig. 4(c) which show individual carbon and polyester fibres respectively past the fracture path of the infused polymerised epoxy resin bondline.

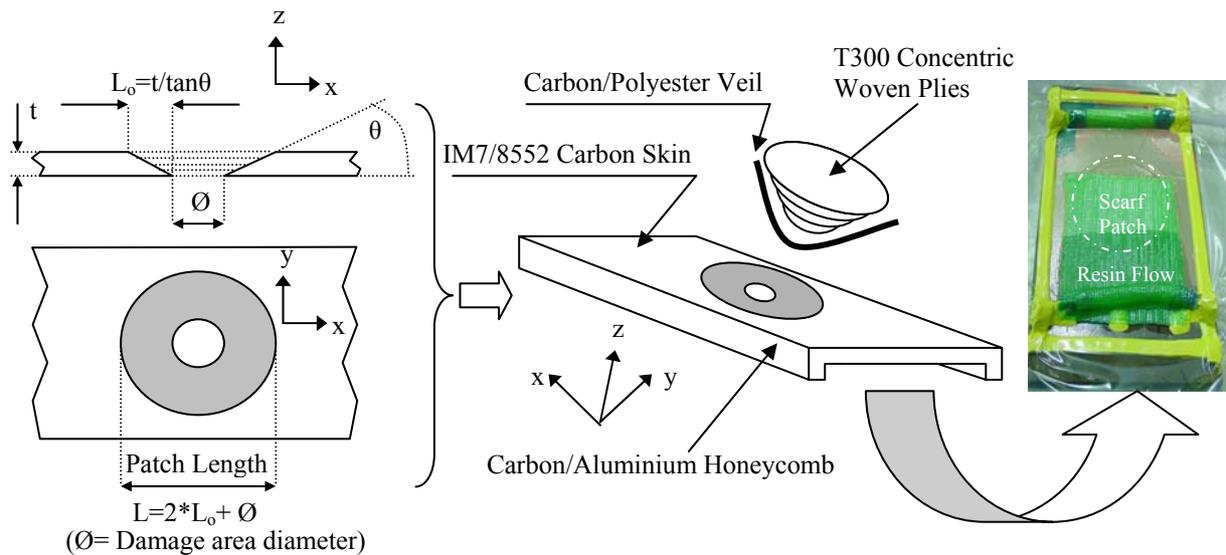
Fig. 5. Scarf design and vacuum infusion repair of the component

The damage representing a ballistic impact was in the form of a 20mm diameter hole in the centre of the element. The area around the 20mm damage was scarfed manually using a high-speed die-grinder fitted with a 280 grade abrasive pad to a gradient of 1:15. A further 15mm was abraded around the outer perimeter of the scarf in order to remove any surface contamination and therefore to generate suitable bonding surface for the overlap co-infused

ply. A three ply precured carbon patch was bonded to the back face of the panel with a two-part room temperature cure Araldite epoxy adhesive to seal the hole and allow a vacuum to be drawn. The lay-up chosen for the scarf repair patch consisted of ten plies of fabric plus an overlap ply.

The stacking sequence selected was: $[(0^\circ/90^\circ), (0^\circ/90^\circ), (+/-45^\circ), (0^\circ/90^\circ), (0^\circ/90^\circ), (0^\circ/90^\circ), (0^\circ/90^\circ), (+/-45^\circ), (0^\circ/90^\circ), (0^\circ/90^\circ), (+/-45^\circ)]$, where the top over lap ply is the last one in the lay-up sequence. Prior to laying up the fabric a carbon/polyester veil was positioned onto the scarfed recess and extended 15mm passed around its periphery. Then the T300 dry repair plies were assembled over the veil and vacuum infused. The patch during the consolidation and polymerisation process matched perfectly the shape of the scarf recess. Fig. 5 illustrates the design principles of the scarf patch as well as the infusion process while Fig. 6 shows a C-scan of the repaired component indicating the high quality of the manufactured patch.

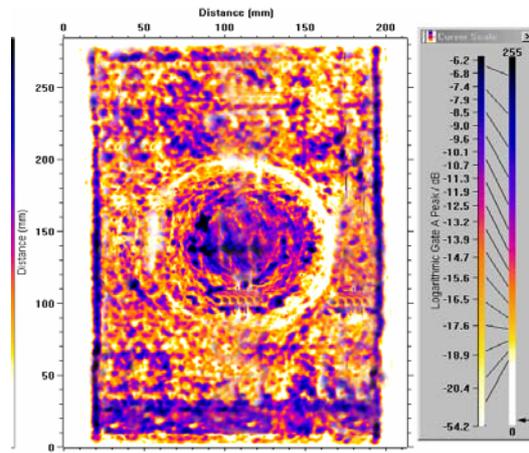
Fig. 6. C-scan of the vacuum infused repaired component

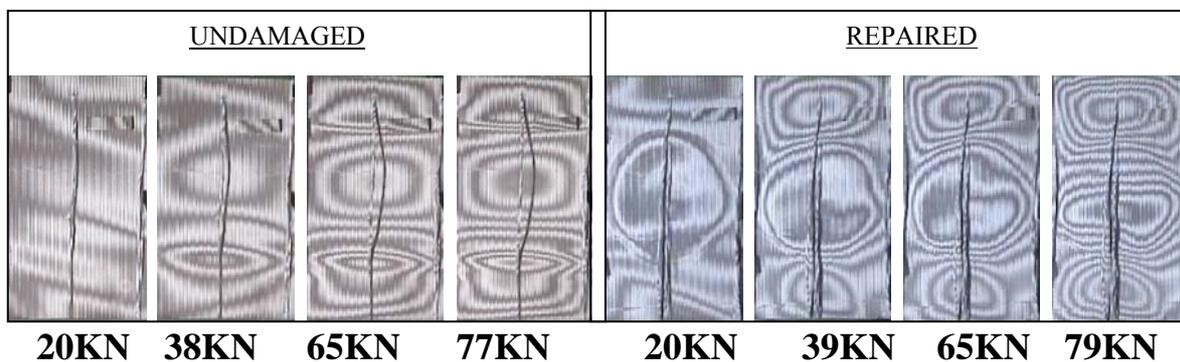
Fig. 7. Shadow Moiré deformation fringe sequence of the undamaged and repaired components under axial compression

The grating was held by two glass plates and attached to a fixture. Collimated light from a standard slide projector was directed towards the component at an angle of 45° measured from normal to the plane of the component. This produced 'fringes' of interference between the grating itself and the shadow caste, by the grating on the surface of the component. These fringes simultaneously served as a datum plane and as an indication of the degree of flexing during testing. Under compressive loading, if the fringes are distorted, they produce interference patterns, which can be considered as deformation contours.

In general, thin monolithic composite skins are prone to buckling and therefore a repair patch on a composite skin must provide high bond strength and increased bondline toughness in order to prevent the out-of-plane forces (peeling and debonding with subsequent crack formation prior failure) developed upon deformation. Since the compressive behaviour of the carbon skin of the components is dictated by the buckling response, it is interesting first to study the representative Moiré interferograms at different load levels. As shown in Fig. 7 for the undamaged baseline element, fringes started to develop at 20kN near the bottom part indicating that some bending occurred without any specific orientation and shape. At 38kN with a clearly defined bulge at the bottom part a second bulge formed in the middle of the component, which lead to a transition splitting into two well defined bulge configurations at 65kN on the upper part. From that load level onwards it is clear that the compressed component buckled in a wavy pattern, creating three well defined bulges (one and a half wave) up to failure. In that stable post-buckling condition, it was observed that the aspect ratio of the three defined bulges was not similar. This may be associated with the lay up of the carbon skin and the edge honeycomb cell stiffeners judging from the tight confinement of the vertical fringes near the edges of the top and bottom bulges. The interferograms showed that the patch affects the overall mode of deformation relative to the undamaged component. A fringe pattern was defined initially at 20kN around the patch perimeter, signifying that the patch induces an outward deformation. At 39kN three clearly defined bulges were developed with the top one showing the highest fringe density. An increase in the fringe patterns was observed at 65kN and as the load reaches 79kN, which is the load at failure, the middle bulge where the repair patch was located seemed to be suppressed in favour of asymmetric bulging at the top and bottom. A profound asymmetry is observed again in the aspect ratios of the bulges regarding their distribution in both vertical and horizontal axis.

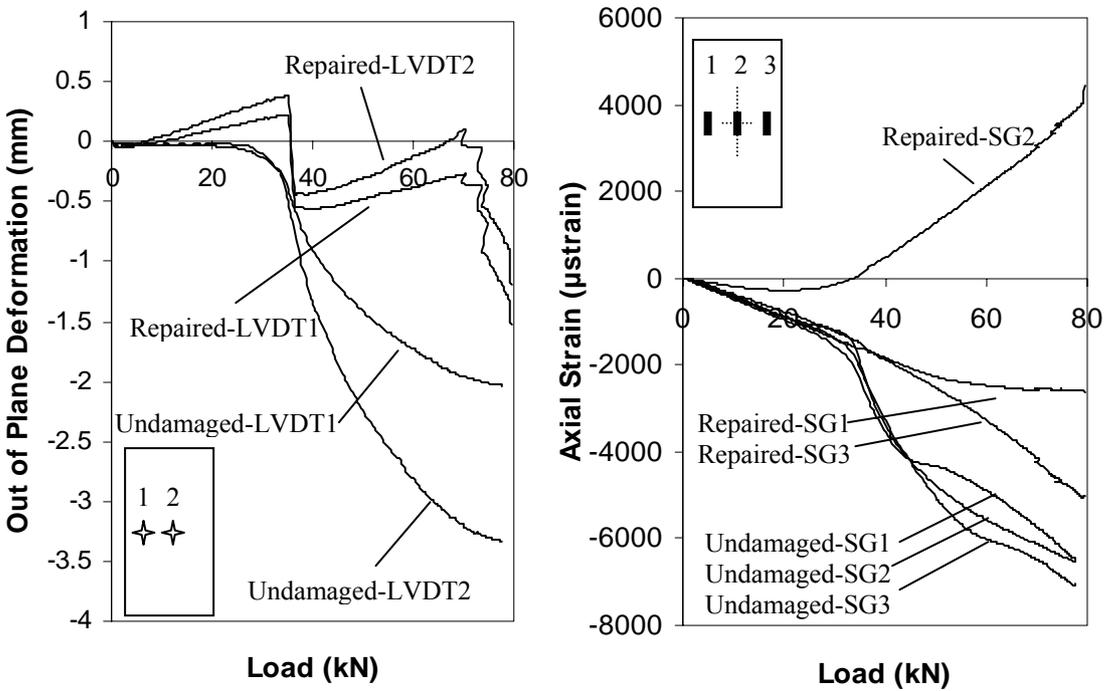
Figure 8. Comparison of out of plane deformation-load and axial strain-load traces as obtained from LVDTs and strain gauges positioned on the undamaged and vacuum infusion repaired components

Fig. 8 compares the traces obtained from the LVDTs positioned in the central area of the components. For the undamaged component, both LVDTs showed a dramatic increase at around 38kN implying that the component buckled at that load level, with LVDT-2 (positioned in the centre) attaining an ultimate value of 3.4mm. It may be assumed that the applied load was shared between the skin and the edge stiffeners, in proportion to their stiffnesses (the product of their respective axial modulus and cross-sectional area). Therefore, the out-of-plane deformation in the middle of the component (carbon skin) is expected to have been higher than at its edges where the stiffeners were located. On the other hand, the patch (especially the co-infused overlap) affected to some extent the global stiffness and therefore the buckling behaviour of the component. The eccentricity of the carbon skin from the patch guarantees that some bending occurred initially, (LVDT reading of around 0.4mm) as the applied displacement was increased. Buckling occurred at 39kN with both LVDT traces having considerably lower values implying resistance to out-of-plane deformation and thus development of significant high peel stresses on the patch. In the region of 70kN the traces showed a sudden unstable jump prior failure.

For many aircraft primary composite components, the design ultimate loading is the level giving a strain of 4000µstrain (fully factored). This level provides a large safety margin between the likely strains in service (two-thirds of 0.4% strain level) and the material failure strain. The strain gauges attached on the surfaces of the undamaged component recorded compressive strains in excess of the design limit as shown in Fig. 8. Due to buckling the strain gauge traces are not linear although symmetric up to the load level of 45kN.

For the vacuum infused repaired component the strain gauges SG1 and SG3 positioned outside the patch area close (25mm) to the edge stiffeners showed compressive strain to failure 2600 μ strain and 5000 μ strain respectively, implying asymmetric deformation across the width. This comes in agreement with the unevenness observed prior failure of the central bulge of the repaired component as recorded from the Moiré fringes. The strain gauge reading SG2 located on the patch itself revealed considerably lower values up to the critical buckling load due to the local stiffening effect of the infused patch. Thereafter, a dramatic increase, which has been recorded as a tensile strain since the SG2 was located exactly on the buckling crest, attained a strain value of 4537 μ strain. If only the strain gauge reading SG2 located on the patch is to be used as the strain level for evaluation of the vacuum infusion repair approach as a potential in-field process, then the ultimate strain value obtained exceeds the critical design limit of 4000 μ strain.
