# PROGRESSIVE DAMAGE CHARACTERIZATION OF STITCHED, BI-AXIAL, MULTI-PLY CARBON FABRICS COMPOSITES

M. Vettori<sup>1</sup>, T. Truong Chi<sup>2</sup>, S. V. Lomov<sup>2</sup>, I. Verpoest<sup>2</sup>

## ABSTRACT

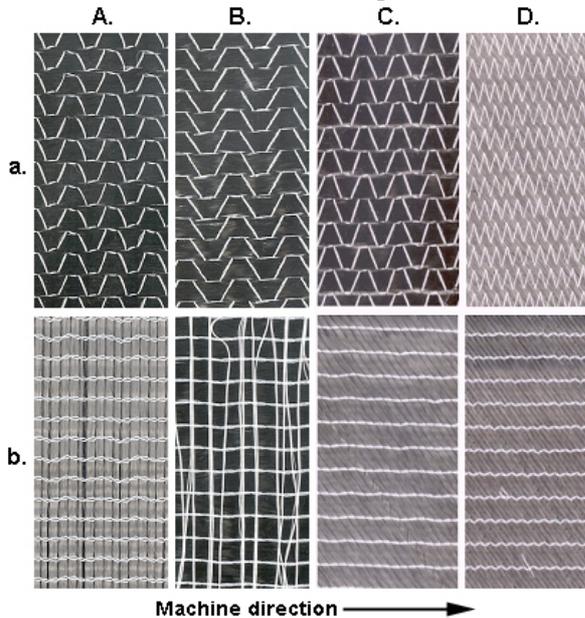
Fig. 1: Multi-axial Multi-ply Carbon Fabrics.

In recent years, the interest of composite manufacturer has been attracted by partially stacked UD fibre-reinforced composite materials. This new family of textiles (Fig. 1), well known as knitted fabrics, and referenced as multi-axial multi-ply fabrics (MMFs), overcomes many of the problems related to the use of unidirectional preregs [1], [2]. These fabrics are made of unidirectional plies stacked sequentially in a number of possible orientations relative to the fabric warp direction. Individual plies are kept together by stitching yarns [3], [4]. The particular architecture of these materials, characterized by the nominal absence of fibre curvature, overcomes the crimp factor problem, providing full use of fibre mechanical properties.

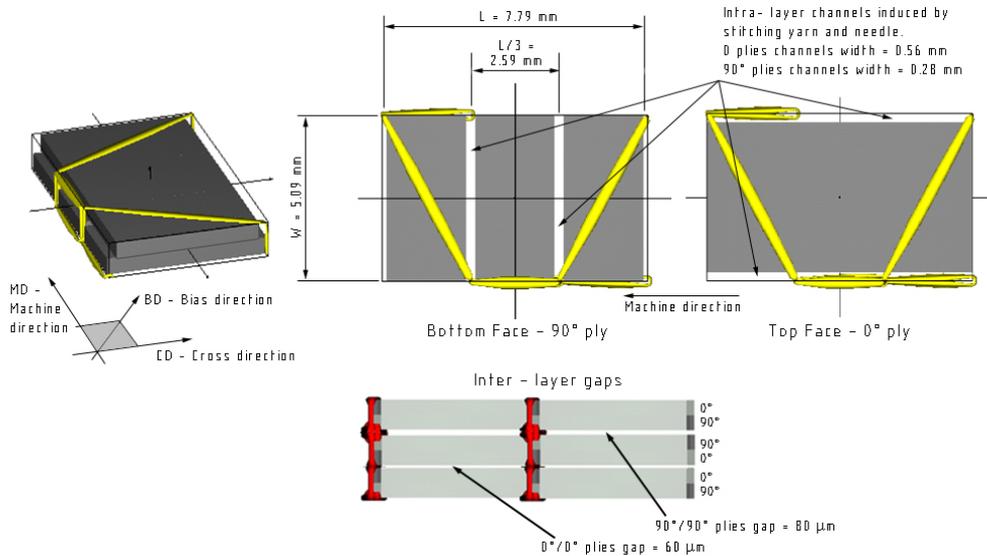
**Fig. 2:** Biaxial multi-ply carbon fabric nominal architecture and geometry. Unit cell and stitching induced defects are represented together with their averaged dimensions.

As discussed in [4], stitching creates disturbance on the uniform placement of the fibers. The action of the stitching needle, and the presence of the yarn introduces in the fabric some defects such as “cracks”, “channels” and “gaps” when laying up the fabrics together. All of them can cause resin rich regions in the composites that can affect the mechanical performance, and the damage initiation and evolution mechanisms under loads. Characteristic dimensions of the elementary cell of the material, corresponding with the stitching characteristic dimensions are presented in Fig. 2, together with disturbances dimensions.

The tests were carried out in different directions defined relatively to the fabric production process (Fig. 2): machine direction (MD) – corresponding to the 0° layer direction; cross direction (CD) – corresponding to the 90° layer direction and bias direction (BD) – corresponding to the  $\pm 45^\circ$  direction. In Fig. 4 typical stress-strain curves are presented together with AE events counts, event energy and cumulative energy parameters. For now is sufficient to observe that for each curve it is possible to identify three different regions accordingly to AE event frequency (see 4.1 for detailed discussion). In order to characterize damage process and identify damage modes at different strain levels, into each one of this strain fields, for each test direction, a particular strain level has been chosen. Six tensile tests were then carried out until each strain level, along each test direction. X-ray radiographies and ultrasonic scans (USS) were then used onto the damaged specimens in order to reveal and identify damage.

Along the machine direction, damage periodicity length varies in a broad range, differently from cross direction where one characteristic length is dominant. Comparing these lengths with fabric's unit cell dimensions (Fig. 2) there correlation is good. L1 in MD is very close 2.59 mm that is the typical distance between subsequent needle holes. L4 in MD is also corresponding with the unit cell length in machine direction. L1 in CD is close to the width of the unit cell (5.09 mm – measured in cross direction relatively to the fabric).

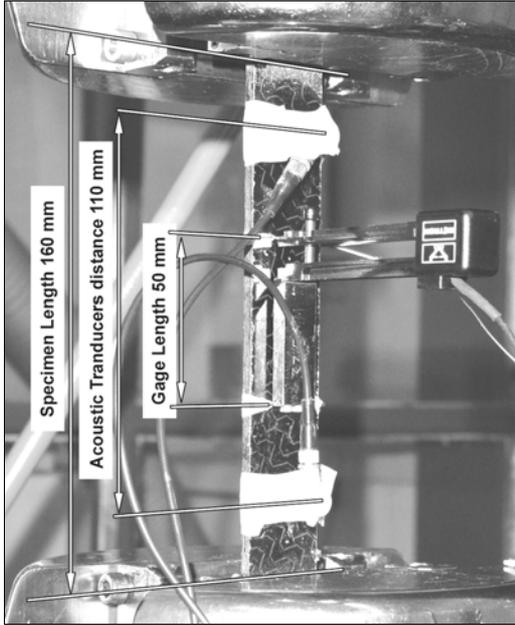
Fig. 3: Instrumented specimen.

Initially, acoustic emissions (AE) were recorded during preliminary tensile tests performed accordingly with the ISO 527-4, onto a 100kN Instron 4505 tensile testing machine. An extensometer with a 50 mm gage length was applied centrally to the specimen, together with two acoustic transducers placed at a relative distance of 110 mm, along the load direction (Fig. 3).

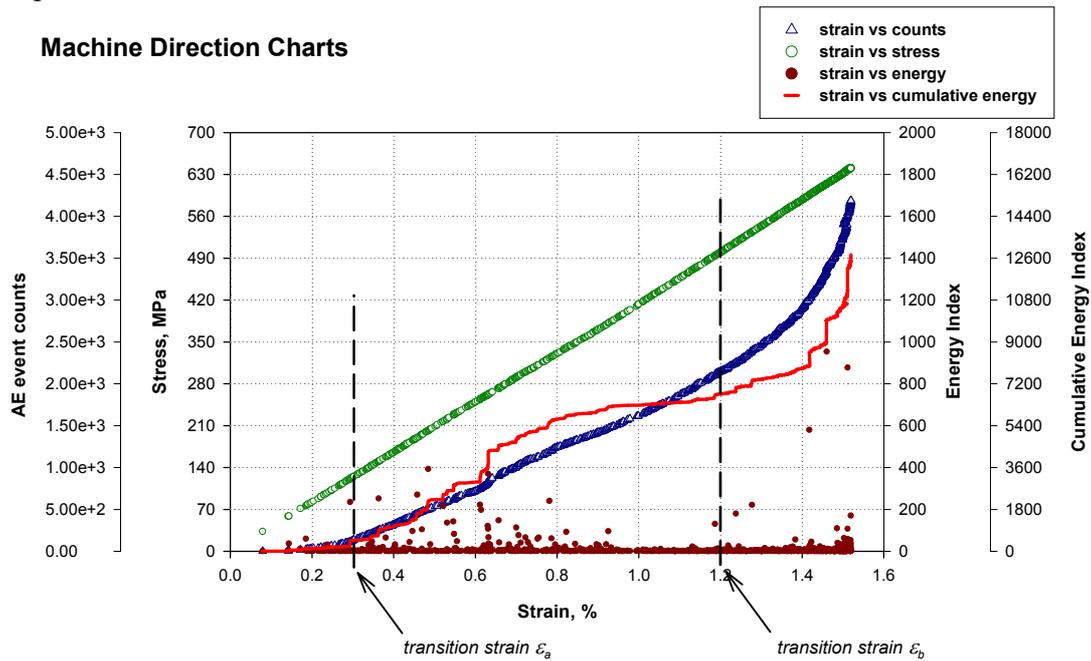
4.a

**Fig. 4.** Stress and strain curve together with acoustic emission counts, events' energy for machine and bias directions. Charts in cross direction are similar to machine direction charts.

As already introduced, Fig. 4 presents the information obtained from tensile tests coupled with AE records on  $0^\circ/90^\circ$  laminates, along machine (Fig. 4.a), and bias (Fig. 4.b) directions; AE counts, stress, event energy and cumulative AE energy are plotted versus strain. Plots along cross direction, are essentially similar to the one along machine direction.

Very closely after these events, at a typical transition strain (indicated as  $\varepsilon_a$  in Fig. 4) of 0.2% for machine and cross direction, and 2% for bias direction, the frequency of events increase suddenly and the energy content reach higher levels. This field of behaviour, characterized by a constant rate of events, covers a wide range of strains, until high deformations. In bias direction, as indicated by stress-strain charts, accordingly to previous observations [8], the stiffness of the specimen decrease rapidly in the initial region, and from the transition strain it progressively reaches a constant value. For the test in machine and cross direction (Fig. 4.a), stiffness of the material slightly increases despite of micro damage. It is because in this direction, the laminates are fibre-dominated materials and the contribution of matrix to overall stiffness is minor. As we will discuss later, the early damage, prior final failure, is mainly matrix cracks and local delamination hence it doesn't significantly reduce the material stiffness. The stiffness reduction due to matrix cracks is than compensated by stiffness increase due to the increase of carbon fibre stiffness under stretching. In bias direction, instead, the material is matrix dominated and matrix cracking or delamination strongly reduce the stiffness of the material.

At higher strain levels is possible to identify a transition strain field (indicated as  $\varepsilon_b$  in Fig. 4) that separate region two and region three of the charts. For machine and cross direction it is between  $1.3 \div 1.4\%$  and for bias direction  $10 \div 12\%$ . In the third region the damaging behaviour of the material depends on the test direction. Along MD and CD the frequency of the events tends usually to increase unstable, till the final collapse of the specimen. On the other hands, along BD direction, the frequency of events may stay constant till final failure, or progressively decrease until the final separation of the specimen into two parts.

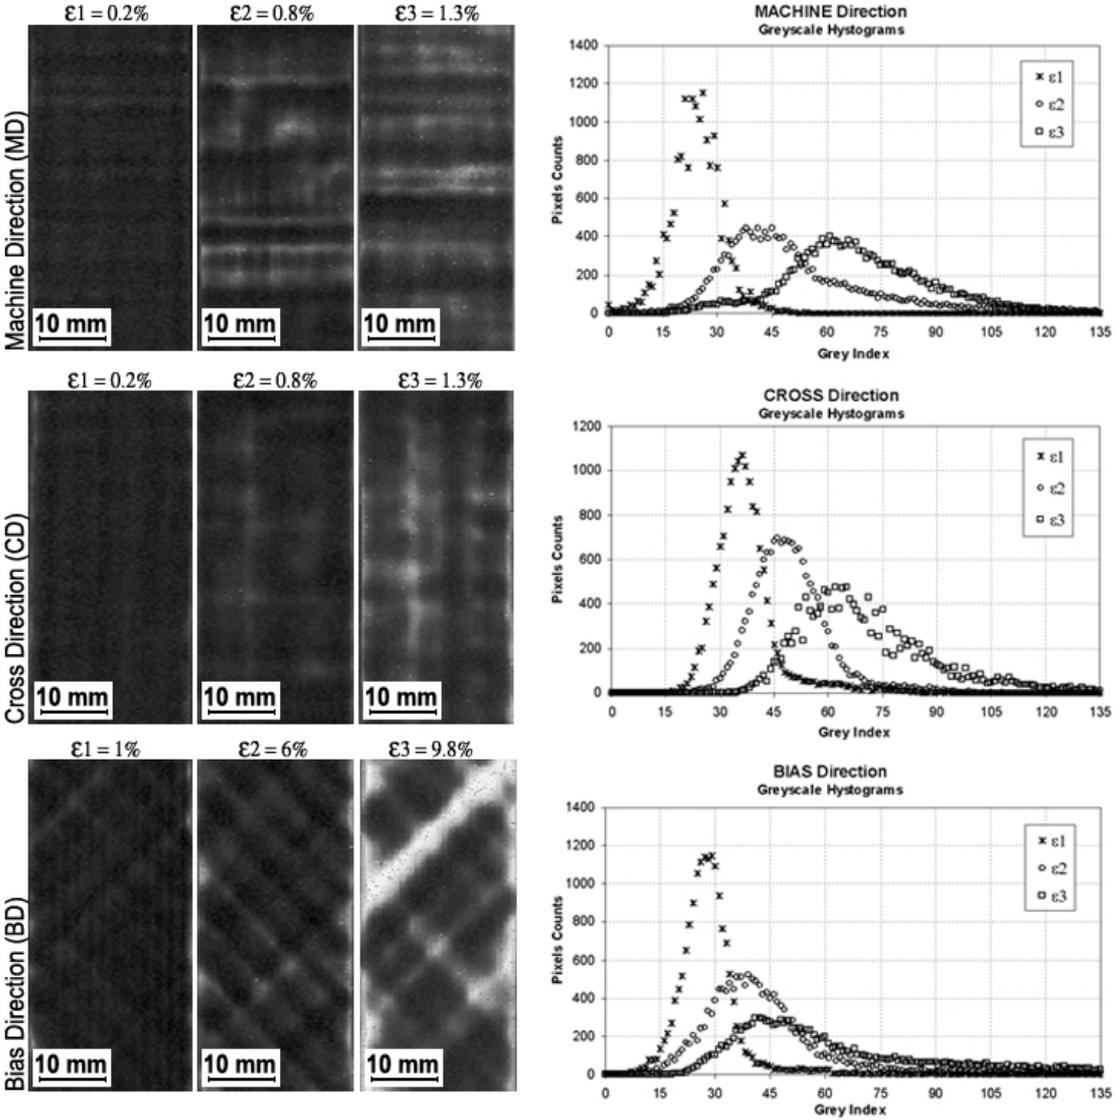
**Fig. 5.** Ultrasonic scanning results. In the left part are presented the greyscale images for test directions and different strain levels. Images are cropped within the gage length of the tests, i.e. with dimension (L×W) 50×25 mm. On the right are presented for each test direction three histograms of a single test at different strains.

and grow into transversal matrix flaws typically interesting the whole width of the specimen. Moreover, bigger cracks (whiter transversal flaws in Fig. 5, MD- $\epsilon_2$  picture and darker ones in Fig. 6 MD- $\epsilon_2$  picture) are surrounded by some delaminated regions identified by USS technique with areas of low intensity grey pixels around whiter transversal lines (Fig. 5, MD- $\epsilon_2$  picture). Transversal cracks are dominant over longitudinal cracks, in spite of some micro longitudinal defects that can be identified. At higher strain ( $\epsilon_3$ ), when the transverse matrix cracks are saturated, longitudinal cracks, due to fibre splitting mechanism, increase and grow, together with delaminations.

For the test in *bias direction*, at lower strain ( $\epsilon_1$ ) matrix cracks along fibres, beginning with cracks in  $+45^\circ$  relative to loading direction, are observed (Fig. 5 and Fig. 6, BD- $\epsilon_1$  pictures). At higher strain ( $\epsilon_2$ ), these matrix cracks develop increasing in number and forming longer cracks oriented both in  $+45^\circ/-45^\circ$  relative to loading direction. Most of them run from one edge of the specimen to the other. Small delaminations develop from the edges following existing matrix cracks. Some delaminations are generated also from inside the specimen, at crossing of  $+45^\circ/-45^\circ$  matrix cracks, as revealed by whiter spots in Fig. 5, BD- $\epsilon_2$  picture. Increasing the applied strain towards the end of the test ( $\epsilon_3$ ), one or more of the delaminations grow interesting the whole width of the specimen, generating specimen failure.

To characterise the damage evolution integrally, it is useful to analyse greyscale histograms from USS images. Taking a window of the specimen coincident with the extensometer gauge length ( $W \times L = 25 \times 50$  mm), greyscale histograms have been calculated for each test direction at each strain level. In Fig. 5, beside USS images, are presented the resulting histograms for each test direction (for the sake of clarity only one histogram for each strain level is presented). Damaged regions appear whiter on the USS images so that the number of “white” pixels, whose grey scale is above a threshold, can be used as an estimation of damage extension. Generally, as applied strain increases, the peak of histogram decreases, while its width increases, moving also toward higher grey indexes, meaning that the image is getting “whiter”. Observing the histograms at  $\epsilon_1$  strain level, the grey intensity of pixels is generally in a range between 20 and 60 for each test direction, that is too low and narrow to create

at strain level  $\varepsilon_1$ , damaged area is close to 0, and damages are seen mainly near the edges of the specimen (Fig. 5). It is believed that the detected damage at  $\varepsilon_1$  is due to edge effects, which is not the case in a structure. Therefore damaged area along MD and CD, can be assumed as zero. Along *bias direction* damaged area at  $\varepsilon_1$  is bigger than in MD and CD, and some damage can be detected also from inside the specimen. Damage at  $\varepsilon_1$  along bias direction, cannot be neglected: although some damage is imputable to edge effects, some developing micro matrix cracks may be appreciated, too.

Observing the images presented in Fig. 5 and Fig. 6, some periodicity in damage may be appreciated. In order to investigate the reasons of these periodicity a measurement of its typical dimensions has been carried out.

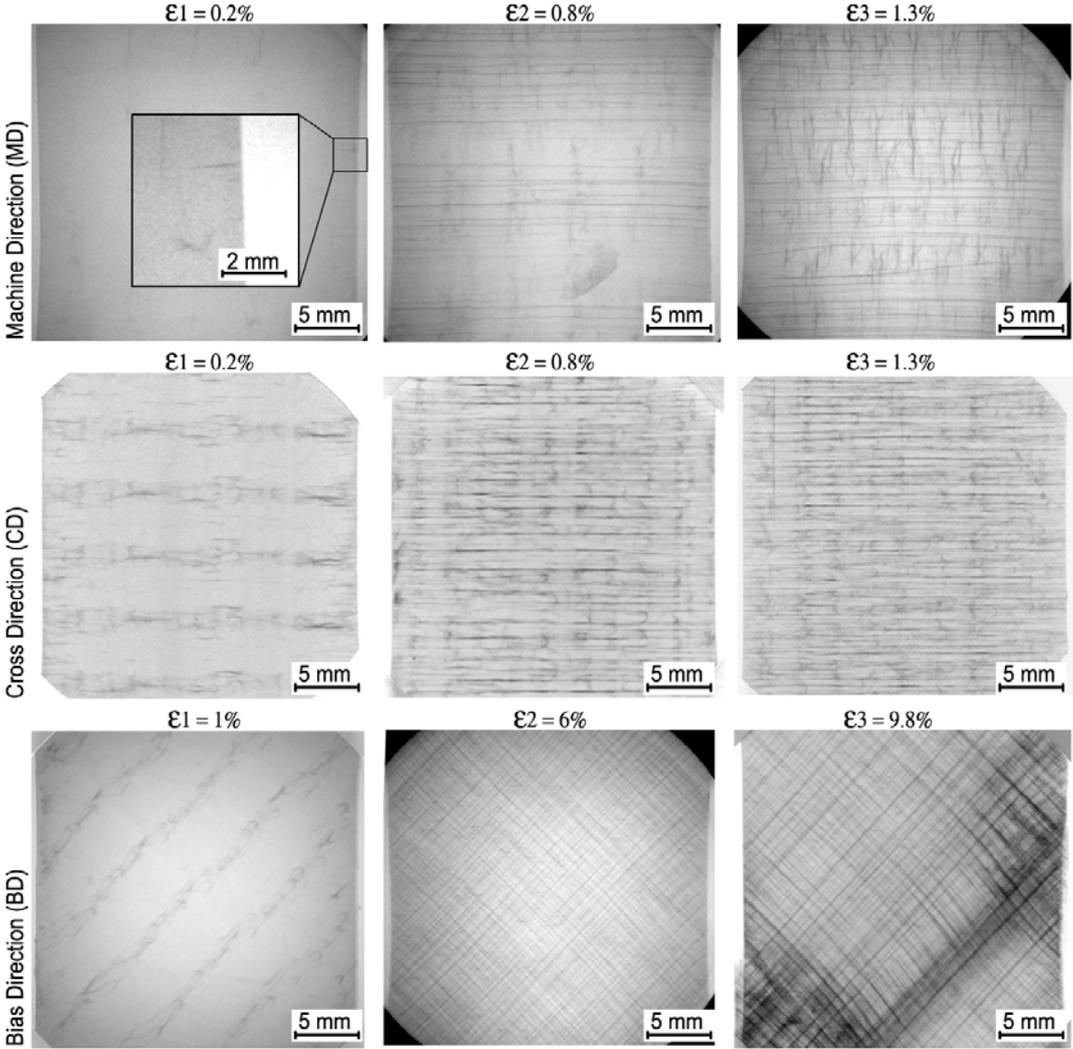
Fig. 6. X-Ray Radiographies. Images are taken in the centre of the specimen, inside its gage length, with dimension (L×W) 25×25 mm approximately.

micro matrix cracks since strain  $\varepsilon_1$ <sup>1</sup>. These generally few cracks, are always oriented transversally and starts from one edge of the specimen as shown in the detail box of Fig. 6, MD- $\varepsilon_1$  picture.

In *cross direction*, similar damage process is involved. At strain  $\epsilon_1$  some longitudinal micro-matrix cracks are detected, here starting both from the edges and from the inside of the specimen (Fig. 6 CD- $\epsilon_1$ ). They increase rapidly in number and dimensions at strain level  $\epsilon_2$ , till strain level  $\epsilon_3$ , where some longitudinal cracks may be detected. Moreover some delaminations can be identified by USS images growing both along transversal and longitudinal direction.

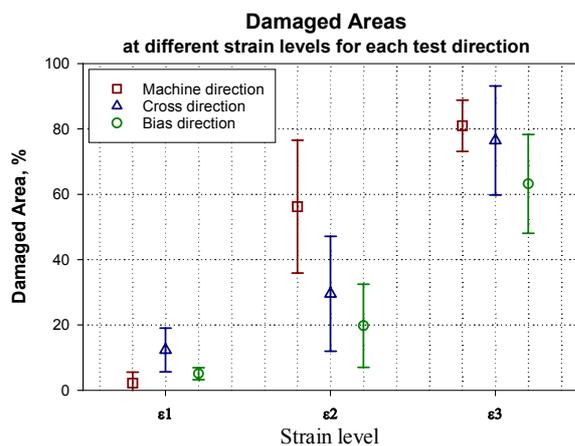
Fig. 7. Results from damage area calculations, presented for each test direction and strain level.

Moreover, the “damaged area” of the specimen can be measured quantitatively applying a threshold filter to USS cropped images. In order to have reliable indication on “damaged area”, one undamaged specimen in machine direction has been chosen as reference. Its USS histogram fit well with a Gauss distribution of average value 34 and standard deviation 4.9. In order to calculate damaged area, a threshold value of 49 (mean + 3 standard deviation, i.e. the 99% of the histogram pixels), has been used for image filtering, results presented in Fig. 7.

It is quite logical to observe “damaged area” increasing when applied strain increases along each direction. However, in MD and CD, damage increases gradually with the applied strain, while along BD it increases more slowly at low strain levels, and faster going from  $\varepsilon_2$  to  $\varepsilon_3$ . This behaviour it is due to the significant contribution of the delamination mechanism, that in bias direction, after a certain strain level, it is the main damage mode. Delamination was also observed by eyes on the surface layers of the specimens.

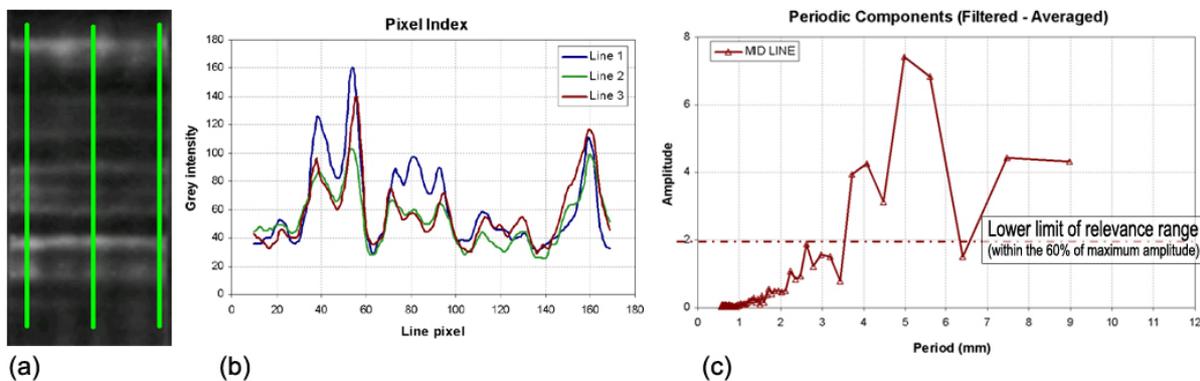
**Fig. 8.** Example of periodicity analysis in machine direction.

Periodicity can be well identified in USS images taken at strain  $\varepsilon_2$ . Different measuring lines has been drawn on these images aligned with load direction for MD and CD, and aligned at  $\pm 45^\circ$  relative to load direction for BD (Fig. 8.a). Along the measuring lines the grey intensity value of the USS image pixels has been isolated and plotted (Fig. 8.b). The waveform that comes out from each measurement has been treated as a signal, and transformed with Fourier analysis, in order to evaluate its main frequencies (or periods). The final results (Fig. 8.c) is a group of characteristic distances between damaged areas, along the paths described by the different measurement lines. In order not to consider measurement noise, before processing the images, they have been submitted to average filtering with 3 pixels radius. Moreover, from the different periodicities evaluated, have been considered only those with amplitude within a relevance range of the 60% of the maximum amplitude, as shown in (Fig. 8.c). This analysis aim at appreciating damage periodicity inside each fabric, overcoming the effects of the stacking process, that create a phase error between different layers which are superposed shifted one in respect to the other. The results from Fourier analysis are summarized in Table 4, where the characteristic distances between damages for each test direction are reported.

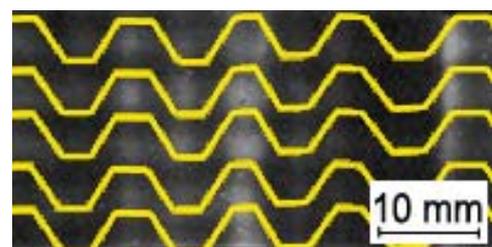
**Fig. 9.** Stitching pattern superposed with the damage pattern for a MD specimen.

Hence damages follows stitching pattern, in its growth process. This result is confirmed by superposition of stitching pattern onto the damage pattern obtained by USS technique, as shown in Fig. 9.
