DEVELOPMENT OF A SMART COMPOSITE PATCH METHODOLOGY FOR THE CONTINUOUS HEALTH MONITORING OF AIRCRAFT REPAIRS

ABSTRACT

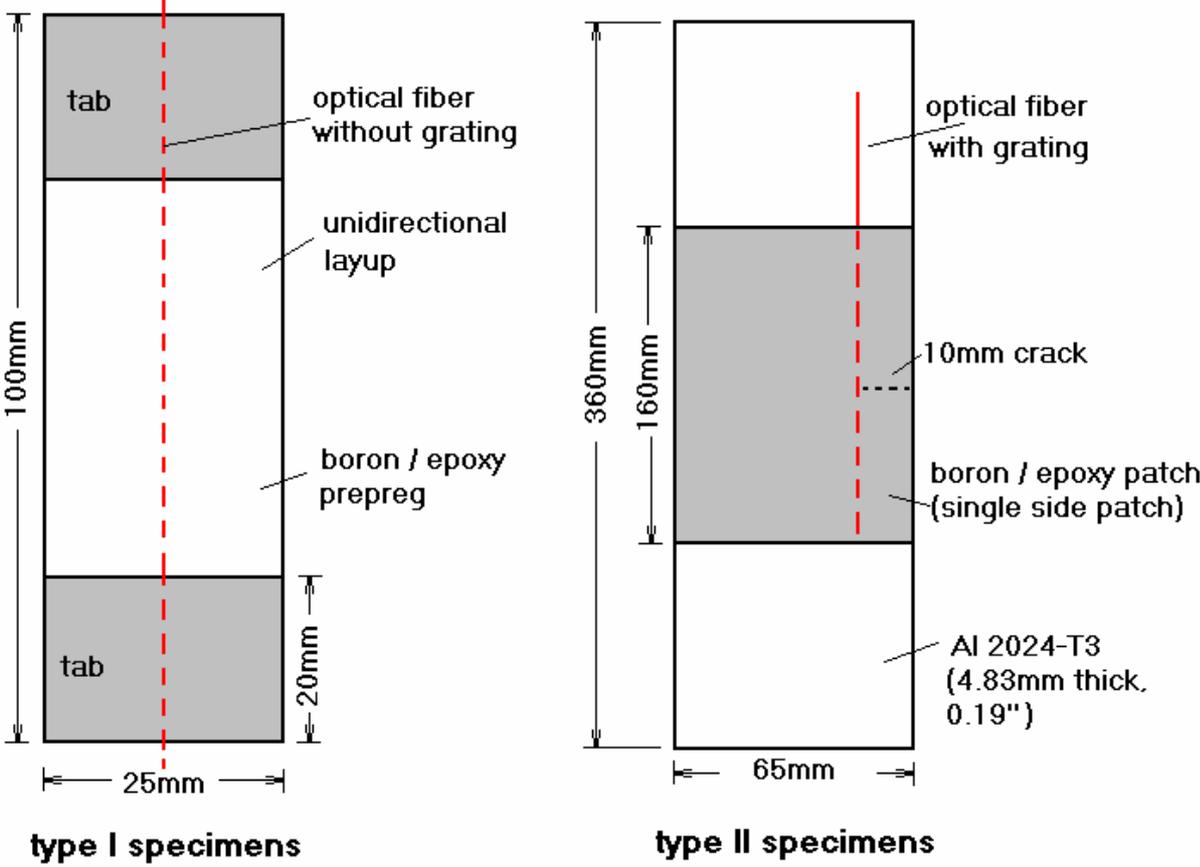
fig. 1

Fig. 1. Type I and type II specimens

Two types of specimens, type I and type II, were prepared (Fig. 1). The type I specimens were tension coupons with an embedded optical fiber (Fig. 2). They were made of Textron 5521 boron / epoxy prepreg cured in the autoclave. Glass / epoxy tabs were cocured with the boron / epoxy prepreg for gripping the specimens in the loading machine.

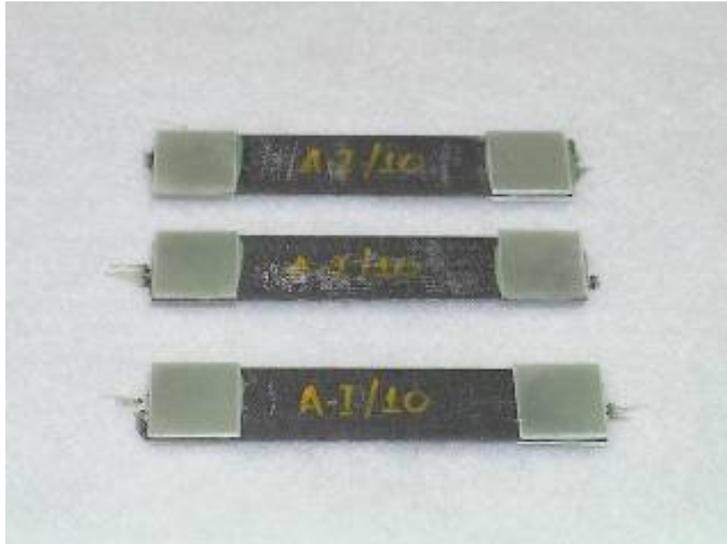
Fig. 2 . Type I specimens with Bragg optical fibers

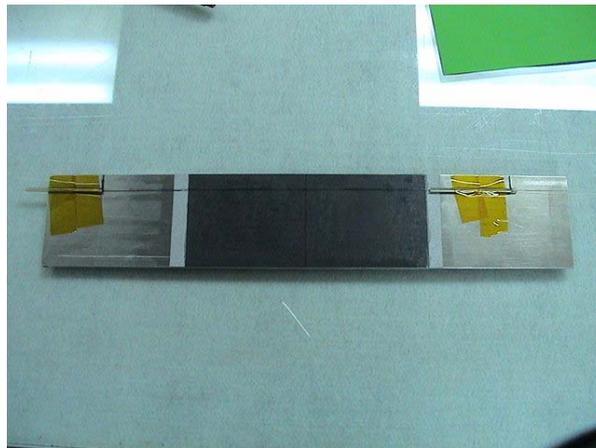
Fig. 3. Type II specimens with Bragg optical fibers

The type II specimens are cracked coupons patched with composite patches. The cracked coupon was made of Al 2024-T3 aluminum alloy and the patch of Textron 5521 boron / epoxy prepreg (Fig. 3). The boron prepreg is adhesively bonded onto the aluminum plate via Araldite 5138 epoxy adhesive. The process used for curing was hot bonding.

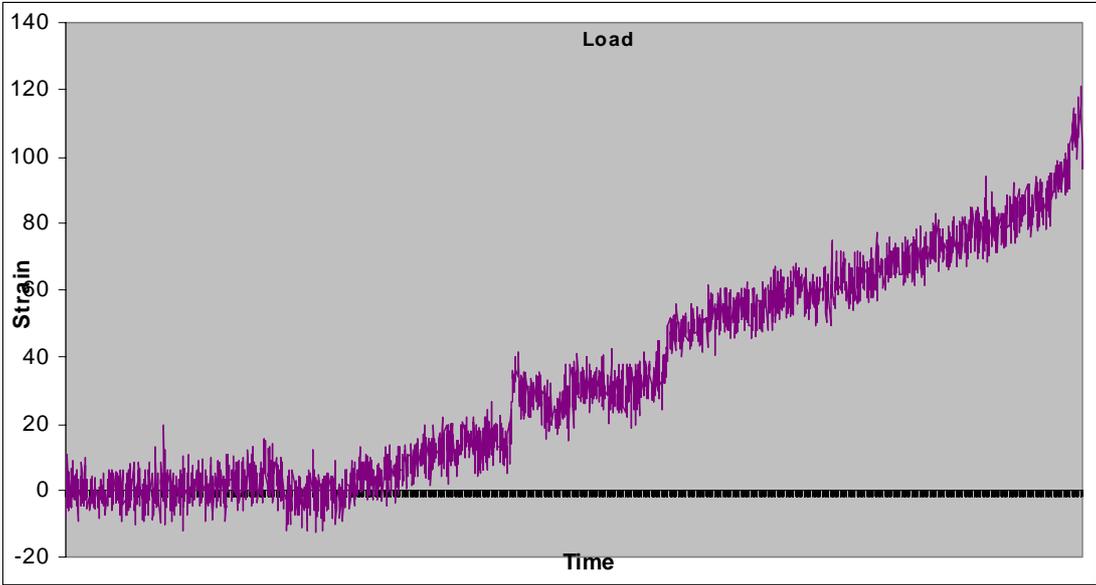
Fig. 4. Strain versus time curve obtained by the Bragg optical fiber measurements

Fig. 4 shows the strain measured by the fiber Bragg grating as a function of time, while Fig. 5 shows the applied load as a function of grip displacement (time). Finally, Fig. 7 shows the corresponding strain versus load curves.

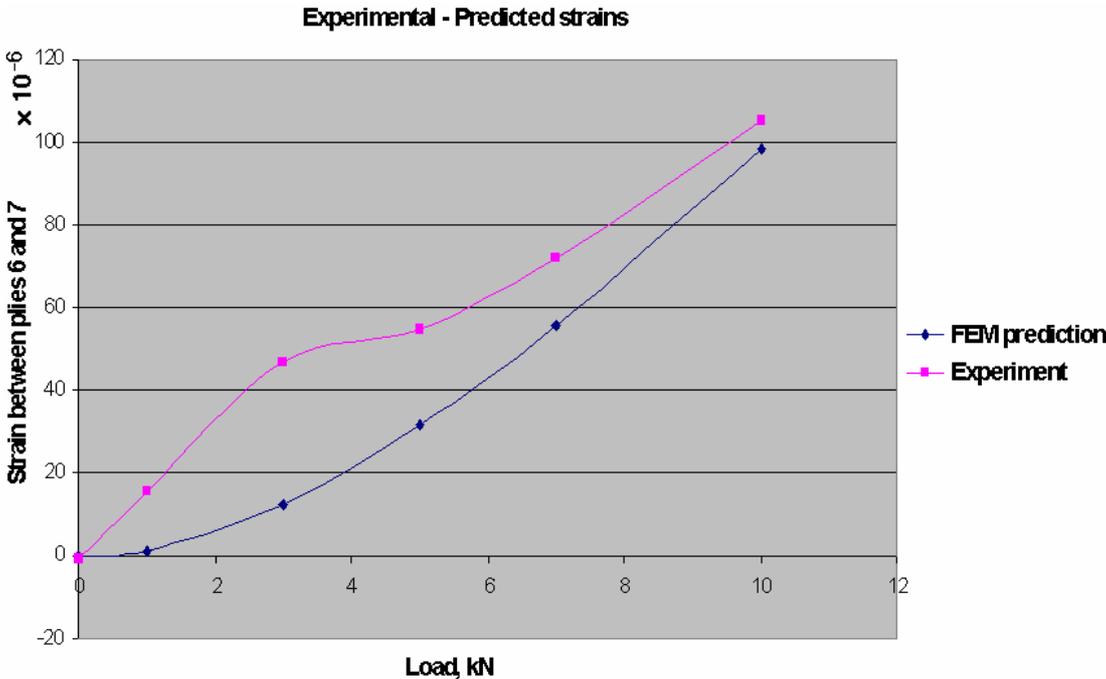
Fig. 5. Experimental and finite element curves of strain versus load. Strains are measured in the composite patch between plies 6 and 7.

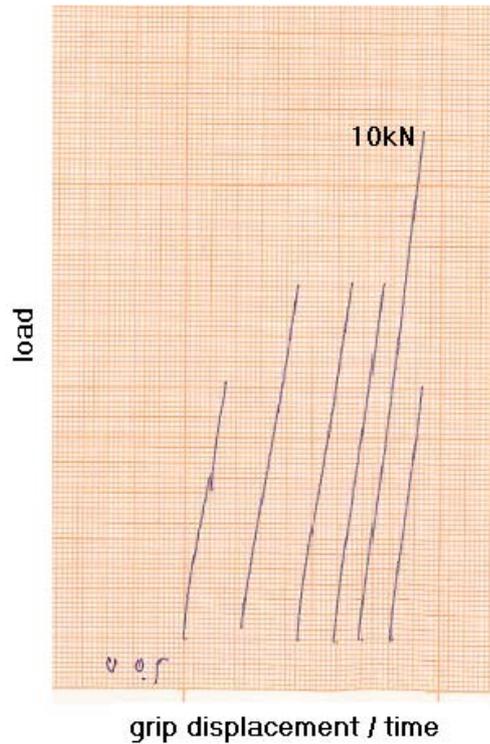
Fig. 6. Load versus grip displacement curves
