Application of a Lamb Wave Technique for the Non-Destructive Inspection of Composite Structures

K. Diamanti¹, J. M. Hodgkinson¹ and C. Soutis²

ABSTRACT

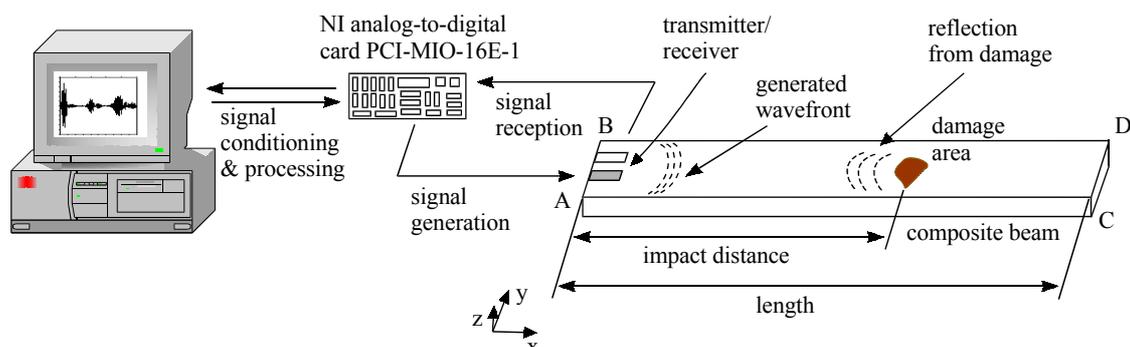
Rectangular piezoceramic elements, supplied by Maplin Electronics U.K. Plc. were used as transmitters or receivers. They were mounted using instant glue at one edge of the composite specimens operating in pulse-echo mode. A Pentium II personal computer and an analog-to-digital PCI-MIO-16E-1 card together with LabVIEW software by National Instruments U.K. Ltd. were used to generate the signal, excite the transmitter and subsequently acquire and process the data from the receiver. The inspection strategy described here is shown in Figure 1.

Figure 1. Schematic of the experimental set-up.

Radiography was used as an alternative inspection method. No damage was evident on the X-ray images after 5 J impact in the sR51 specimen. A debond between the skin 1 and the core appeared after 10 J impact across the whole width. This ranged from 170 mm to 240 mm from the transducers location (Figure 1). For the beam with the denser foam sR71 damage first appeared at a higher impact energy level of 15 J. A debond immediately below the impact point was generated. Cracks developed at the edges of that debond in the core that propagated through the core and led to debonds on the opposite skin. Delaminated layers could also be seen at the surface of the top skin. The damage area ranged from 160 mm to 230 mm across the length of the specimen.

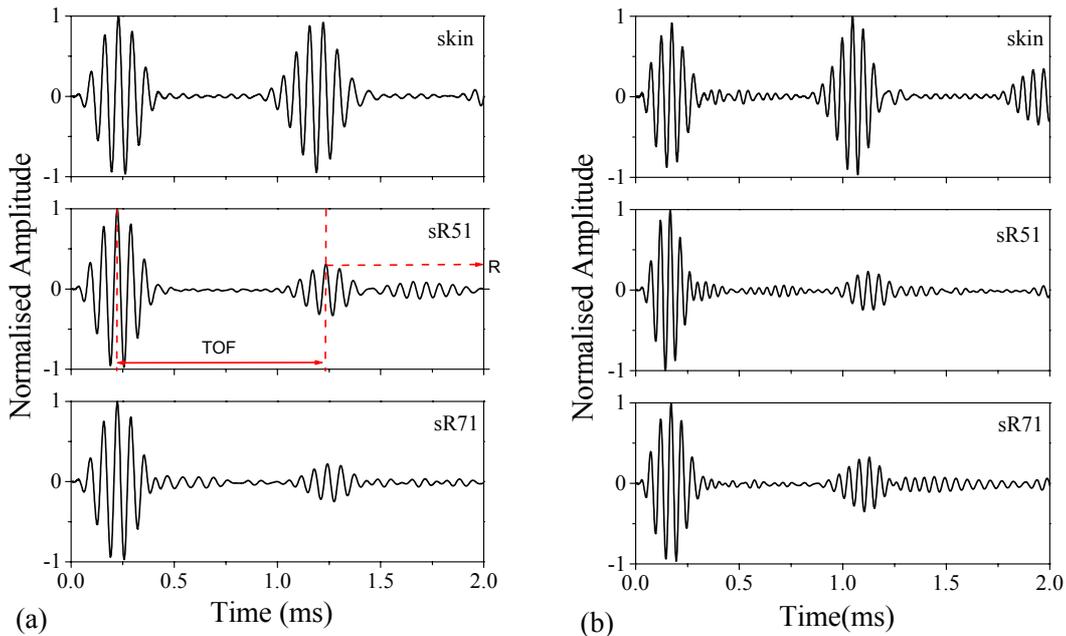
A beam specimen was cut from the quasi-isotropic laminate for comparison of the wave propagation in the skin to the sandwich specimens. Figure 2 shows the signals acquired from the skin alone and from the sandwich beams (side 1) at different frequencies. It can be observed that no significant changes in the shape or the arrival time of the pulse are introduced by the presence of the foam. However, significant attenuation is present due to energy being dissipated into the core. This allows us to assume that there is leaky Lamb wave propagation [5,6]. Although attenuation is greater, the reflection from the far edge of the beam can still be detected, as can be seen in the time traces, after it has travelled twice the length of the beam, i.e. approximately 1 m. The A_0 mode at low frequencies could therefore be used for the long-range inspection of sandwich structures.

Figure 2 Signals received on the skin alone and the sandwich beams at 15 kHz (a) and 20 kHz (b).

The response of the specimens from a 15 kHz excitation signal was captured by the two receivers. The transmitter and receiver 1 (top surface) were in line with the impact point. The second receiver 2 was on the opposite skin (bottom surface). The reflection coefficient (R) of the transmitted signal and the time of flight (TOF) from the excitation are depicted in Figure 2. These parameters were monitored for the

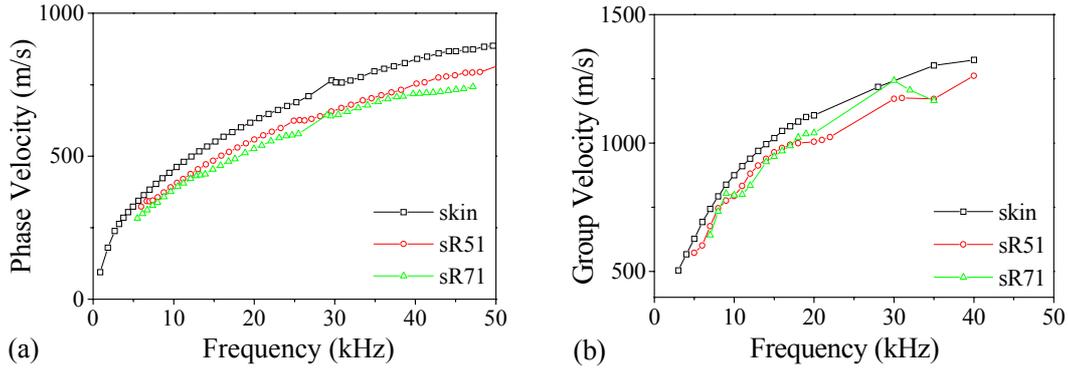
Figure 3 Experimental dispersion curves for the skin alone and the sandwich beams.

The resonant spectrum method [15] was used here to measure the phase velocity of the A_0 Lamb mode for the sandwich specimens. The group velocity was also calculated at various frequencies. The measurements were taken from the specimens having the transducer and receiver on the same side. The dispersion curves for the skin alone were also measured. The results are depicted in Figure 3. It must be noted that the velocities are plotted versus frequency and not the frequency-thickness product. It can be observed that the dispersion curves obtained for the sandwich beams were very close to those calculated for the skin, in accordance with other studies [5-8]. The difference can be attributed to the adhesive because the skin with the adhesive has lower stiffness than the skin alone. The thicker the adhesive layer the bigger the difference [5].

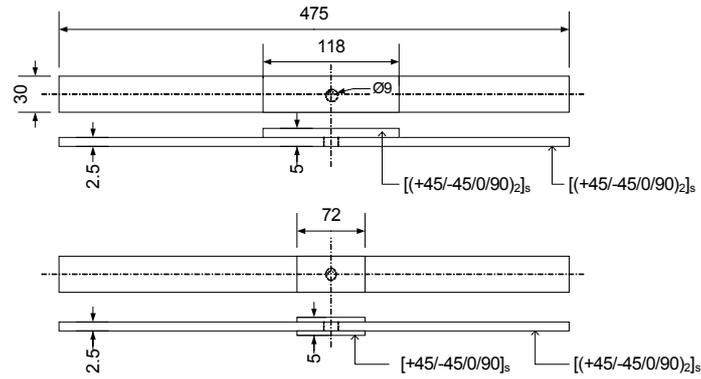
The single (2.5 mm thick patch) and double lap (1.25 mm thick patches) repair specimens used here are shown in Figure 4. Both the parent specimens and patch repairs were manufactured from T700UD/SE84LV UD prepreg tapes supplied by SP Systems to form quasi-isotropic laminates. A 9 mm hole was drilled to represent the removed damaged area, using a diamond coated tip drill piece. The required overlap length was calculated through analytical expressions [18]. No tapering was used. The specimens were 475 mm long and 30 mm wide. An SA80 SP Systems adhesive was used to bond the patches on the specimens. The specimens were instrumented with a pair of 5 by 15 mm piezoceramic elements. A sampling frequency of 1.25 MS/s was used throughout the tests.

Figure 4 Geometry of repair specimens; dimensions in mm.

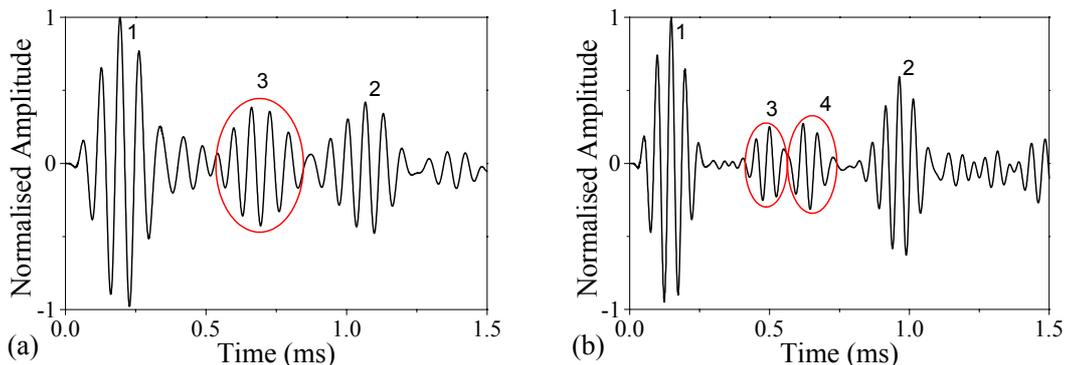
Figure 5 shows the signals received from the double lap repair specimen being excited by a 5.5 cycle sinusoidal pulse in a Hanning window at 15 kHz and 20 kHz. At the frequency of 15 kHz it was observed that the reflections from the two ends of the patch could not be separated and are seen as the signal 3 in Figure 5 (a). However, at the higher frequency, Figure 5 (b), the smaller wavelength permitted a visible time separation between the two pulses seen as signals 3 and 4. Therefore the higher frequency was selected for the inspection of the repair specimens. Similar results were observed in the single lap repair specimen.

Figure 5 Response of the double lap repair specimen at (a) 15 kHz and (b) 20 kHz.

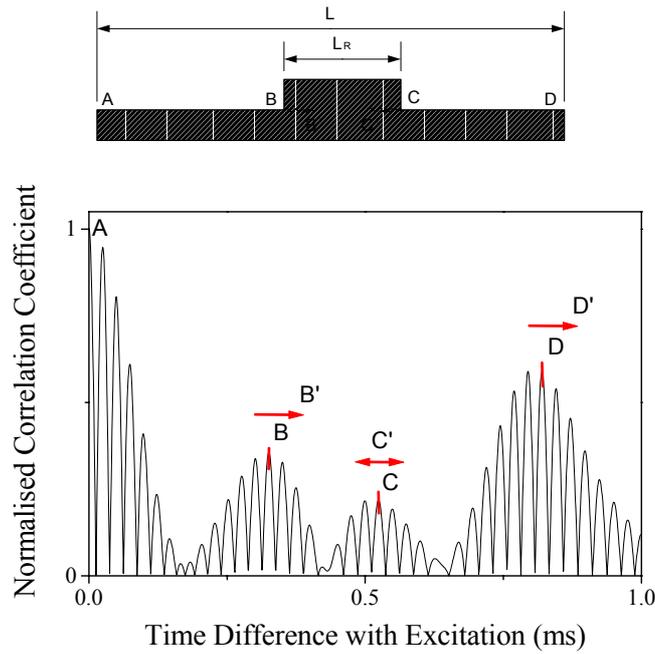
Figure 6 shows a schematic of the single lap repair specimen and the cross correlation coefficient of the monitored response, which is calculated as the product of the excitation pulse with the response of the structure at every time step. In general, when there is a crack below the patch, the propagation path of the wave in the parent specimen increases while the path in the repaired area of the specimen decreases. The wave propagates in the patched specimen at a higher velocity as the thickness at that point is double that of the parent specimen. Therefore in the cracked specimen the length of the parent specimen with the lower velocity increases and that causes the signal travelling through the whole propagation distance to be delayed. As the crack grows from point B to B' (crack length is BB') the peak of signal B will also be delayed. Finally the time that signal C appears depends on the length of both cracks and the relative difference between the velocities of the patched and parent specimen. If there is no debond at the beginning of the patch and the crack has only grown at the end (crack length is CC') the signal C will appear sooner.

Figure 6 Schematic of the single lap repair specimen and the acquired Lamb wave response.

the signals from the edge of the beam A or D and the patch B or C correspond to the lengths AB and CD respectively, Figure 6. When a crack is present the TOF increases. That is attributed to the wave propagation along the cracked part of the specimen, BB' or CC'. In this specimen cracks appeared only in the side of the patched specimen that was in tension. Therefore the velocity for the 3.75 mm thick part of the specimen at 75 kHz mm frequency thickness product was used to calculate the crack length. Good estimation of the crack growth is achieved which is consistent for both specimens.

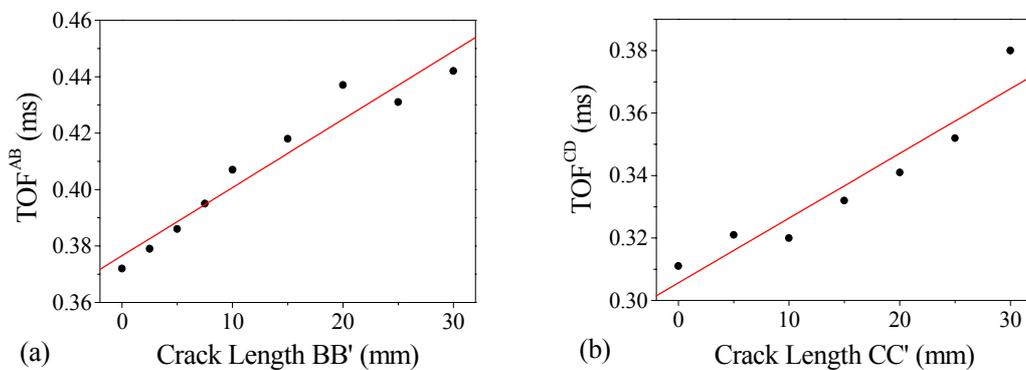
A Finite Element model was built in Abaqus 6.3 [19] to check the TOF behaviour described above. In the analysis 4 noded general shell elements were used for the parent specimen. The patch was also modelled with shell elements on top of the parent specimen using multipoint constraints at the common nodes. A single lap repair specimen was built having the same dimensions as the test specimen. Nodes were disconnected gradually to obtain the response of the cracked structure. Cracks were introduced at the first edge of the patch and the TOF changes between the signals A and B are plotted against the crack length in Figure 7 (a). Deviation from the linear behaviour is expected due to the difficulty of identifying the peak of the signals at low frequency. However, a clear indication of the debond growth below the patch is shown from the delay in the signal. In Figure 7 (b) the crack was gradually increased from side 2 and the TOF between signals C and D is plotted against the crack length.

Figure 7 TOF increase with increasing crack length (a) in the beginning (BB') and (b) end of the patch (CC') from FE analysis.

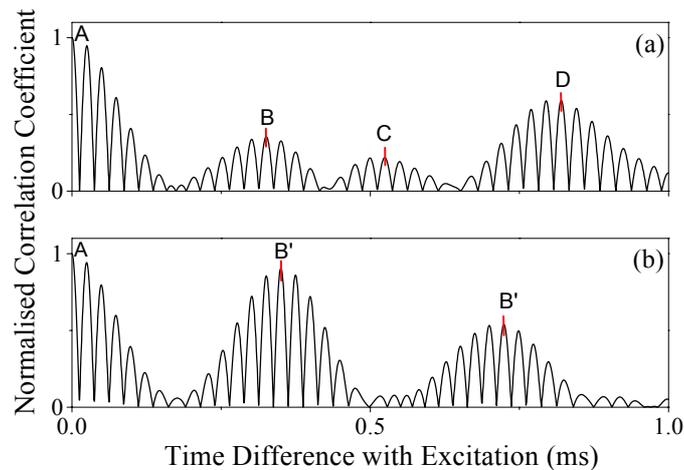
Figure 8 Response of the pristine (a) and damaged (b) single lap repair specimen.

The cross correlation between the excitation pulse and response of the structure was computed to identify the time difference between the separate wave packets. Figure 8 (a) shows the response of the undamaged single lap repair specimen. The group velocities were experimentally measured for the parent specimen of the same lay-up and material at different frequencies and are reported in Table 3. Using these values and the TOF measurements, the length of the various areas in the repaired specimen can be calculated. The results are given in Table 4. Good correlation is achieved for the AB and CD distance but agreement was poor for the BC distance. This is because the velocity used for the wave propagation in that region was taken from the parent material without the adhesive. The presence of the adhesive will decrease the stiffness and therefore the flexural wave velocity in that region.

After the test the cracks BB' and CC' were measured with a magnifying camera, 10 mm and 18 mm, respectively. The response of the damaged specimen is depicted in Figure 8 (b). It can be observed that a very strong signal was reflected from the crack BB' which travelled back and forth within the AB distance causing repeated reflections. The estimated crack length was 12 mm instead of 10 mm as given in Table 4. Little energy was transmitted to the rest of the specimen and the signals from points C and D were not recorded, therefore no information is given for the other end of the patch.
