# THE INFLUENCE OF ASPECT RATIO OF REINFORCING FIBERS ON MECHANICAL PROPERTIES OF GYPSUM MATRIX COMPOSITE PANELS

## ABSTRACT

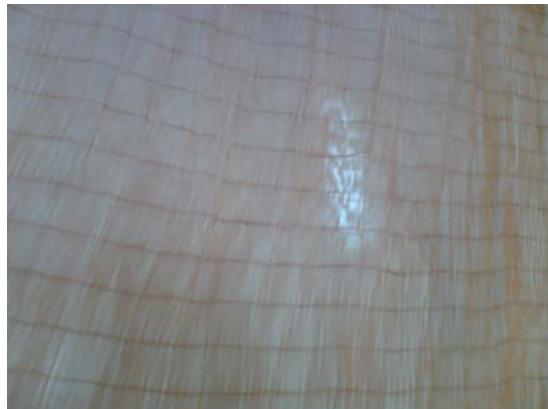
Long parallel Kevlar fibers (see Figure 1) were placed 1cm below and above the top and bottom surfaces of the panel mold. The mixture of water and gypsum were then added to form the gypsum matrix composite.

Figure 1: Long parallel Kevlar fibers used in laminated panels.

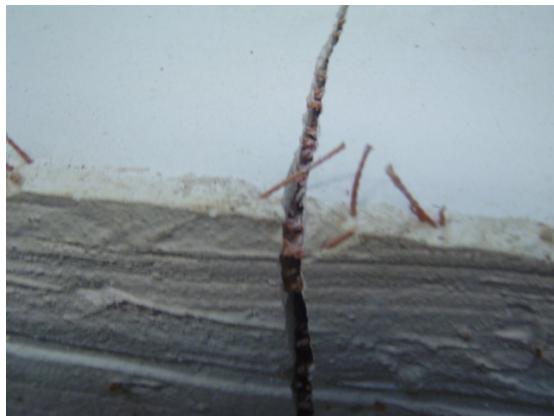
After the maximum point, the matrix fails and crack grows inside it. In such a situation, what hold the two separate pieces of the panels together are the polymer fibers which act as a bridge between the two pieces (see Figure 6). The mechanical bond between the polymer and gypsum prevents full separation of the two panel pieces.

Figure 6: Picture of the cracked matrix: polymer fibers act as bridges between the two pieces.

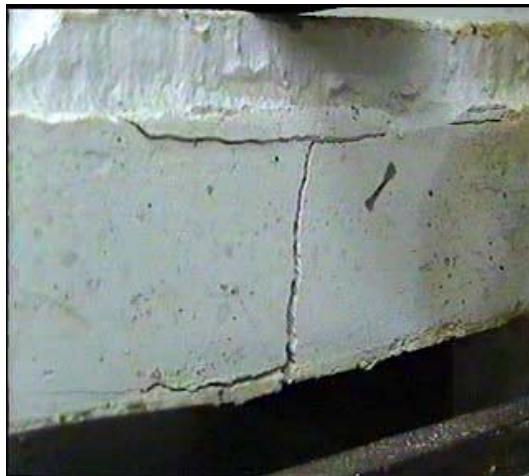
the fiber layer, it cannot pass this strong and elastic layer, and as the bond between gypsum and fibers is not that strong, the crack begins to separate the fibers from the gypsum below. Therefore the gypsum matrix below does not bear any load and is gradually separated from the fibers. The maximum load is tolerated by fibers which are under maximum tensile stress. As these fibers are not stiff, they begin to bend. The gypsum matrix can bear such deformation to a specified limit and after that it fails suddenly with a crack ending in the fiber layers at both sides. Figure 7 shows such a crack.

Figure 7: The crack occurred after the middle layer fails in laminated composite panel.
